Client: 12303B The Springs - Parks + Landscape

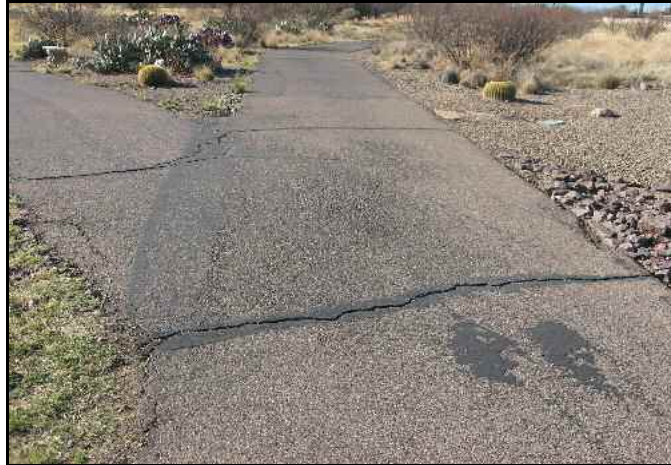
**Comp #:** 202 Asphalt Paths - Replace

Evaluation: Asphalt paths are primarily original from 1996. A small section was added during 2005. The association previously requested no Reserve funding be allocated to replace the paths. However, the asphalt path has a limited life and will eventually require extensive repairs or replacement. Some larger cracks noted.

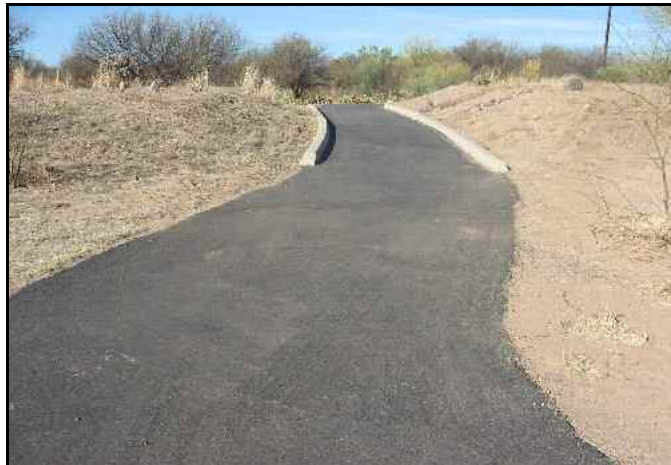
**Comp #:** 204 Asphalt Paths - Patch/Repair

Evaluation: The walking paths do not receive the traffic and heavy vehicles that the main streets receive. There does not appear to be any alligatoring or failing spots developing. There is no expectancy for patchwork and partial replacements for the walking paths. Crack fill and seal coat periodically as recommended.

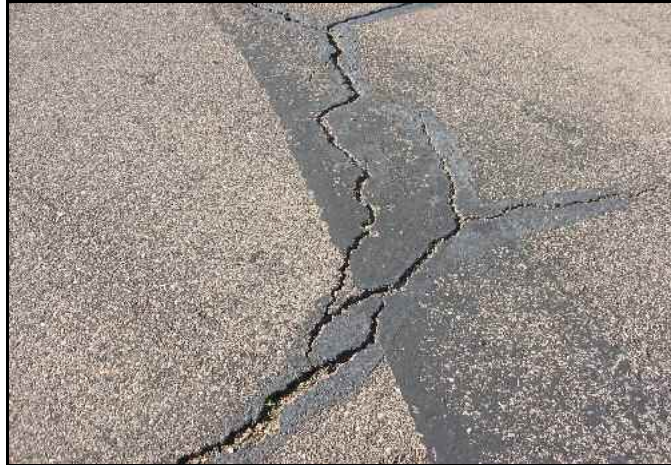
**Comp #:** 206 Asphalt Paths - Crack Fill

Evaluation: Recommend coordinating with crack filling the main community streets if possible. The association plans to crack fill separate from seal coating. Larger cracks in the paths noted.

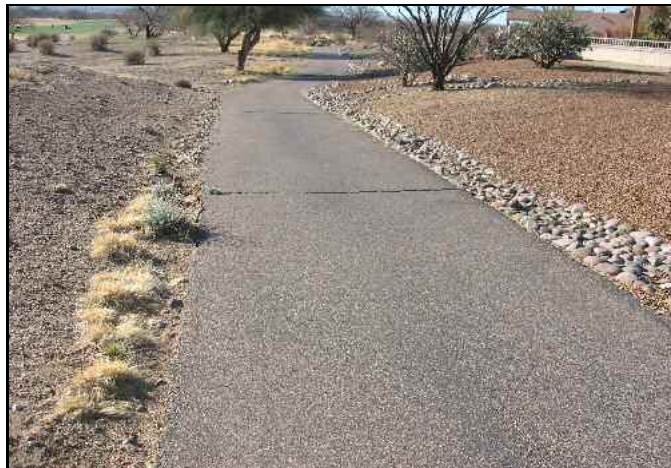
**Comp #:** 208 Asphalt Paths - Seal/Repair

Evaluation: The paths do not appear to have any seal remaining on them. The paths receive less traffic and wear than the main streets, so seal coating should be anticipated less frequently. The asphalt paths have a long life expectancy before replacement, but only if maintained properly.

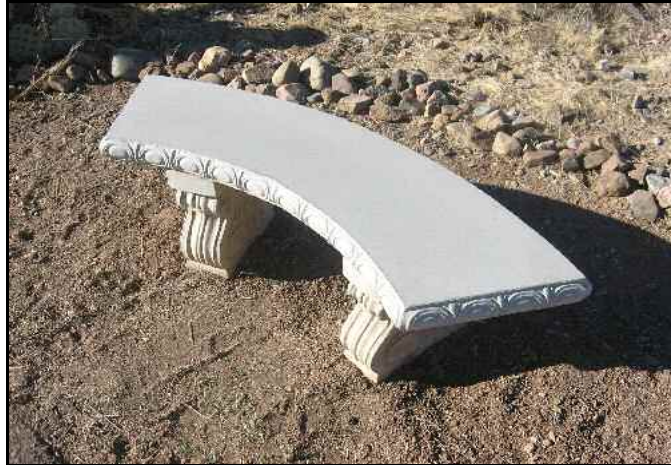
**Comp #:** 404 Concrete Benches - Replace

Evaluation: Benches were installed around 2004. Still in good shape. Normal hairline cracks in the concrete noted. There is no expectancy for complete replacement. Individual replacement is too small for Reserve designation. Replace when needed as an Operating expense.

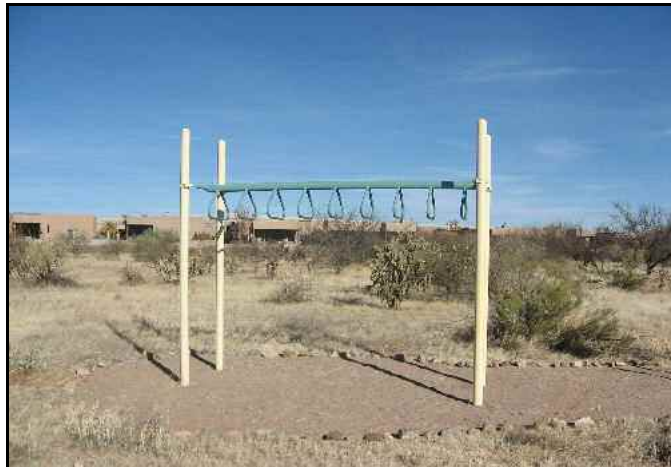
**Comp #:** 410 Fitness Trail - Replace (The Park)

Evaluation: Stations include introduction & warm up, body curl, step up, horizontal ladder, inclined body curl, heart check, beam jump, push up, leg lift, chin up, and cool down. Equipment was installed around 1996. Long life expectancy under normal circumstances. 30-year life span assigned as previously requested by the association.

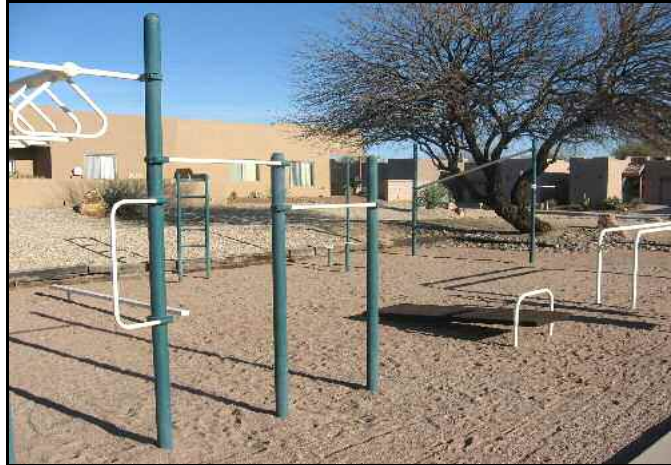
**Comp #:** 411 Fitness Trail - Replace (Park #21)

Evaluation: Trail set-up is very similar to The Park. It is just condensed into a smaller area. Equipment was installed around 1996 and is in fair condition. Fading and wear evident. Long life expectancy under normal circumstances. 30-year life span assigned as previously requested by the association.

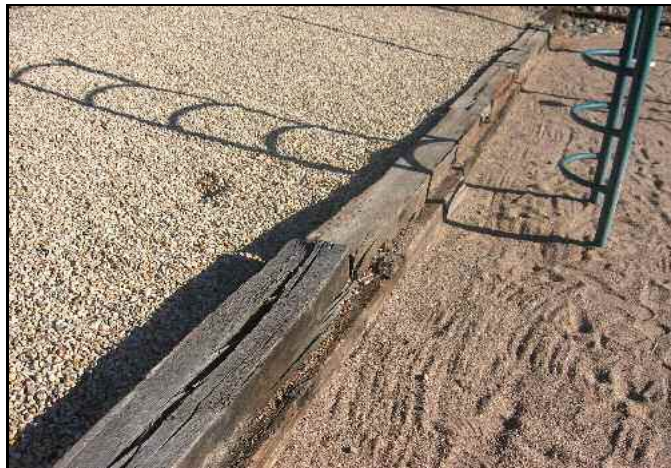
**Comp #:** 412 Wood Timbers - Replace

Evaluation: Installed during 1996. Observed to be older, weathered, and worn. Splitting and cracking noted. Future replacement should be anticipated, but is not a high priority at this point.

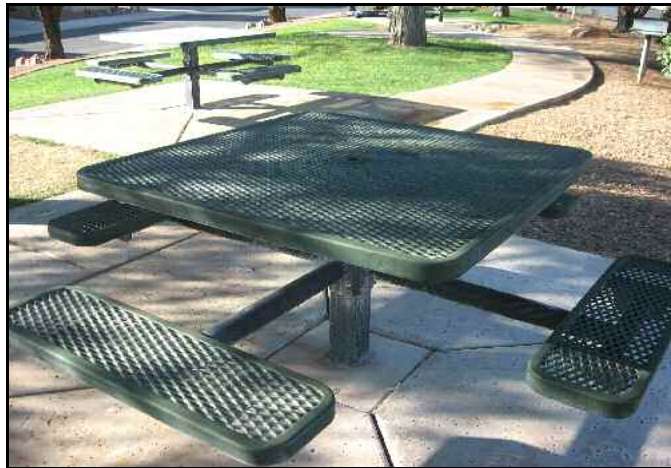
**Comp #:** 420 Park Furniture - Replace

Evaluation: Furniture consists of (6) 46" square picnic tables with 4-attached seats, (2) 6' picnic tables, and (4) 8' benches. All pieces are expanded metal with a plastic coating. Original from 1996. Pieces are hit by the adjacent sprinklers. Moderate fading and discoloration noted. Useful life has been decreased to reflect conditions.

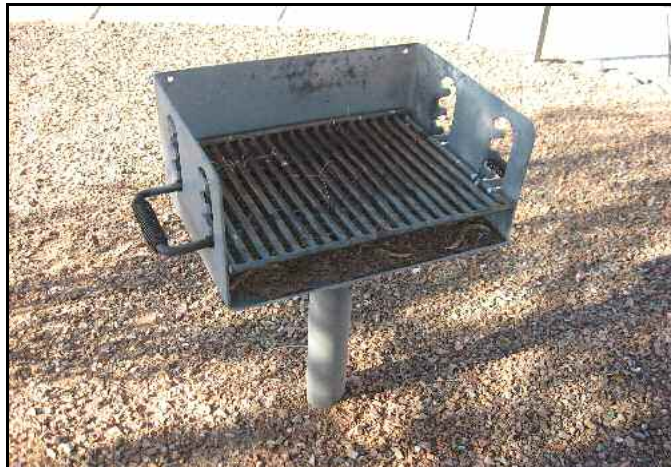
**Comp #:** 422 BBQ Grills - Replace

Evaluation: This park has both a standard size and double size charcoal grill. They are original from 1996 and look older. They do not receive the sprinkler exposure that the park furniture does. The association plans to remove rather than replace the grills in the future, so no Reserve funding has been allocated.

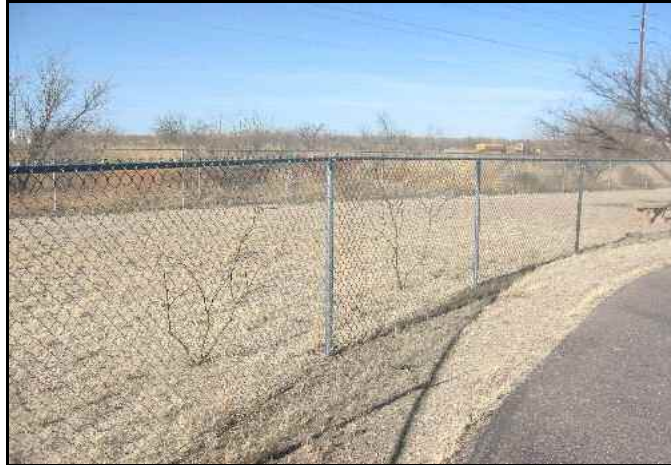
**Comp #:** 502 Chain Link Fence - Replace

Evaluation: The chain link fence enclosure is used for a dog area. This is galvanized chain link. It is still secure and in good condition. No signs of damage or abuse noted. There is no expectancy to completely replace. Recommend repairing or replacing sections as needed as an Operating expense.

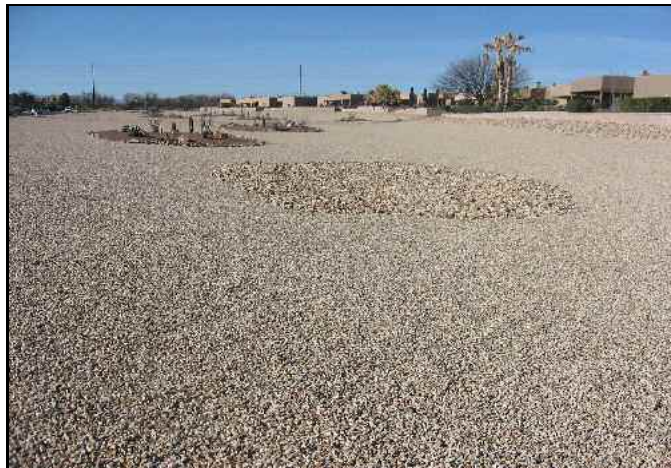
**Comp #:** 1002 Granite (Park #2) - Replenish

Evaluation: The association installed granite in these areas around 2007 for \$33,213. Observed to be full and in good shape. This component provides funding to top dress the existing landscape granite with a new 1" layer.

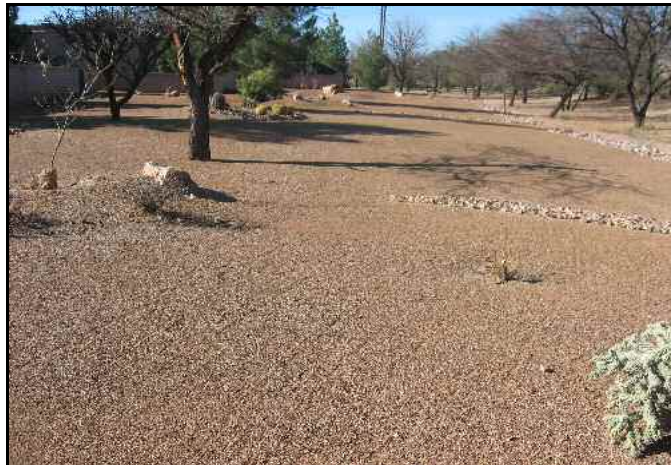
**Comp #:** 1004 Granite (Park #4) - Replenish

Evaluation: Desert park #4 is primarily behind homes. This component provides an allowance to periodically replenish the granite surfaces visible from the street. The granite in this area is original from 2000 with Phase 2 of the community. Rocks are smaller and bare in spots. Useful reflects replenishing with larger rocks.

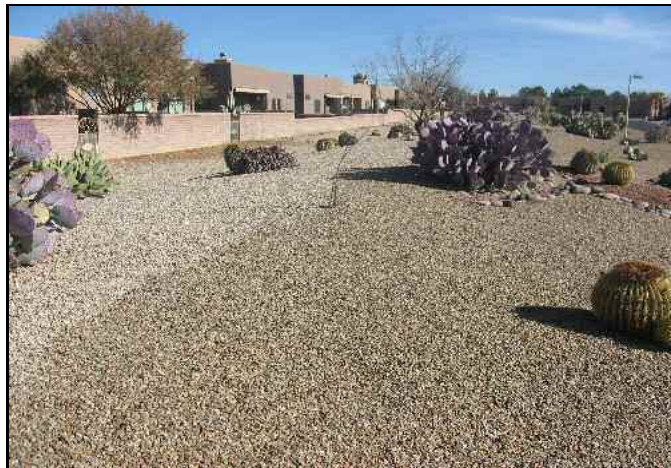
**Comp #: 1006 Granite (Park #6) - Replenish**

Evaluation: Park #6 is approximately 43,200 square feet. The majority of this area was replenished around 2003 for \$8,000. The section not replenished is hardly visible from the street. Surfaces are still full and in good shape. This component provides funding to top dress the existing landscape granite with a new 1" layer.

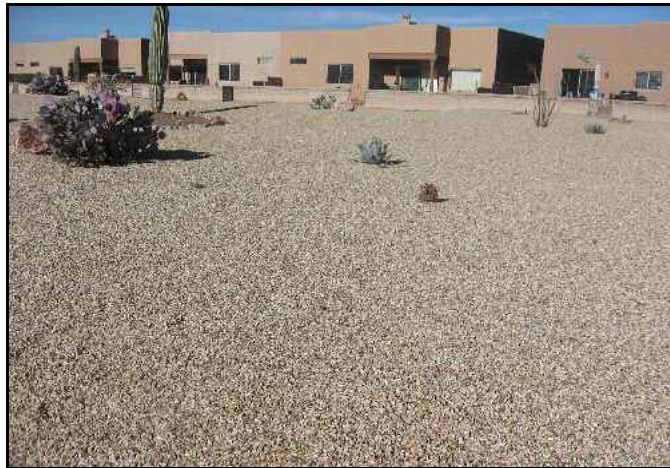
**Comp #:** 1007 Granite (Park #7) - Replenish

Evaluation: Park #7 is approximately 47,100 square feet. The association has spent approximately \$8,450 in the last few years replenishing this area. Appears full and in good shape. This component provides funding to top dress the existing landscape granite with a new 1" layer.

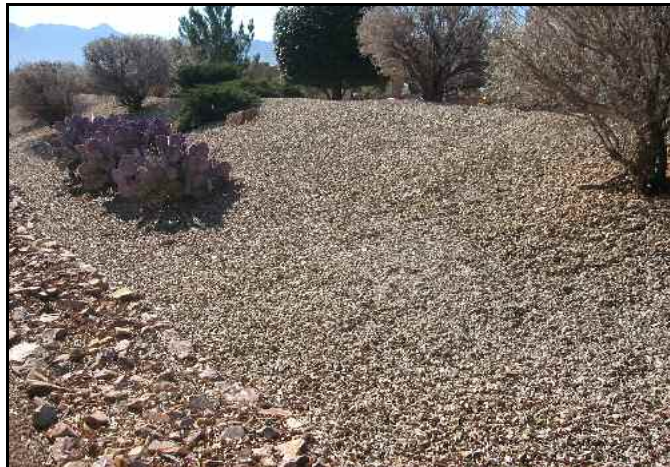
**Comp #:** 1008 Granite (Park #8) - Replenish

Evaluation: Park #8 is approximately 50,738 square feet. We estimate it will take approximately 290 tons of granite to top dress with a new 1" layer. Approximately \$13,000 has been spent in the last few years replenishing this area. Observed to be full and in good shape.

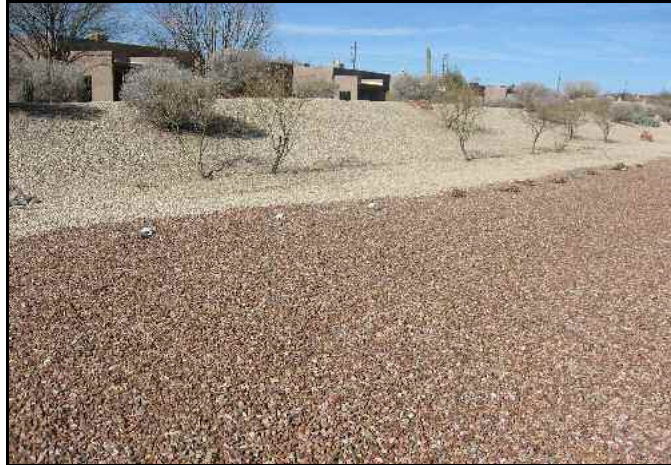
**Comp #:** 1009 Granite (Park #9) - Replenish

Evaluation: The association spent approximately \$15,100 during 2010 to replenish Park #9. Full and in good shape. No bare or thin spots noted. This component provides funding to top dress the existing landscape granite with a new 1" layer.

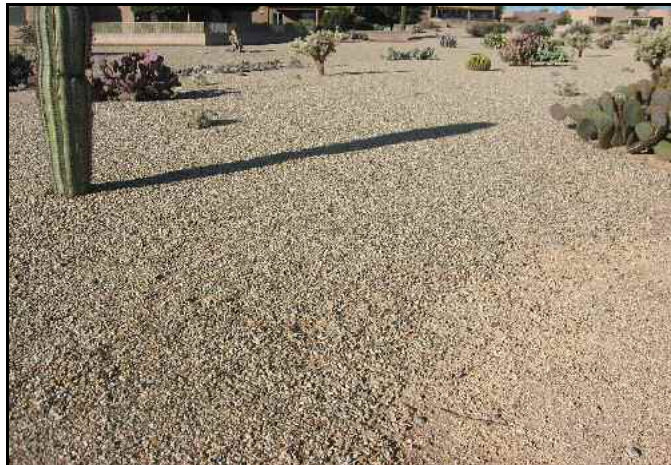
**Comp #:** 1010 Granite (Park #10) - Replenish

Evaluation: Surfaces at Park #10 were partially replenished during 2006-2008. Still generally full and in decent shape. Remaining life reflects current conditions. This component provides funding to top dress the existing landscape granite with a new 1" layer.

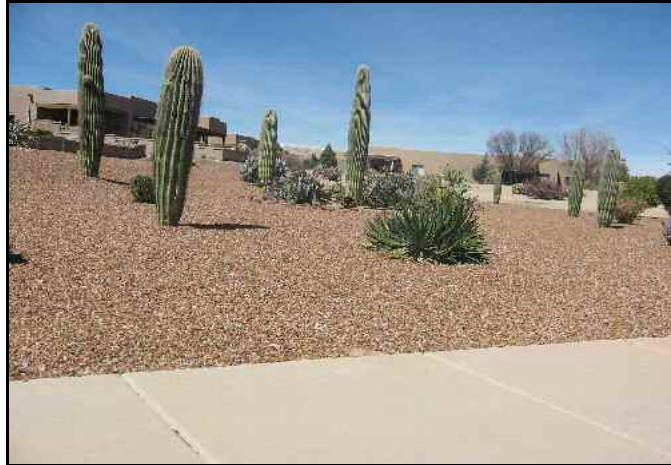
**Comp #: 1011 Granite (Park #11) - Replenish**

Evaluation: A portion of Park #11 was replenished during 2008. Still in decent shape overall. Remaining life reflects current conditions. This component provides funding to top dress the existing landscape granite with a new 1" layer.

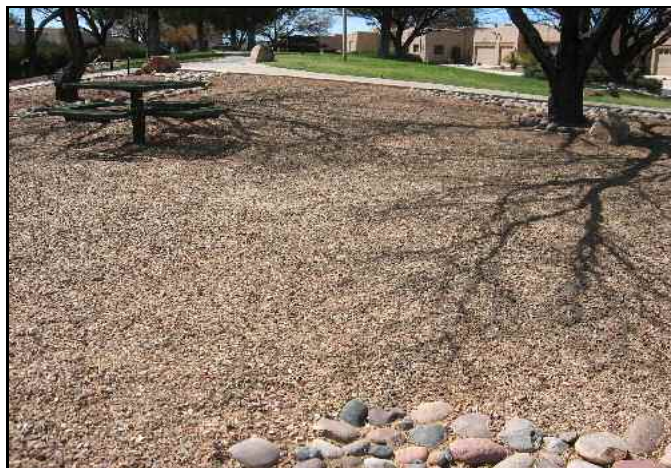
**Comp #: 1013 Granite (Park #13) - Replenish**

Evaluation: Park #13 is approximately 24,750 square feet. It is a mixture of grass and rock areas. We estimate approximately half of the area consists of rock. Surfaces are generally thin and bare. Sections of visible dirt noted. Replenishing should be anticipated at some point in the near future, but is not a high priority yet.

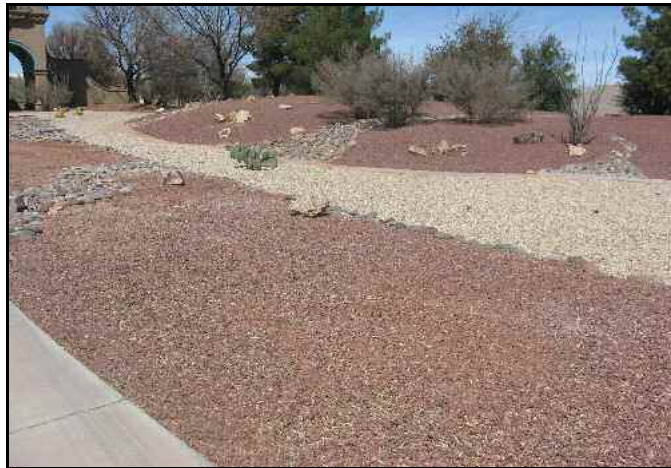
**Comp #:** 1014 Granite (Park #14) - Replenish

Evaluation: Park #14 is generally full and in decent shape. Rock is a little thin in some spots, but very minimal. Overall good conditions observed. This component provides funding to top dress the existing landscape granite with a new 1" layer.

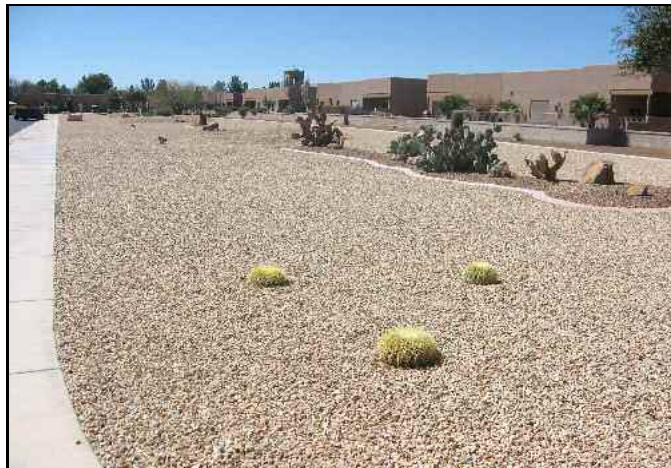
**Comp #:** 1015 Granite (Park #15) - Replenish

Evaluation: The association installed granite in these areas around 2005 for \$9,550. Observed to be full and in good shape. This component provides funding to top dress the existing landscape granite with a new 1" layer.

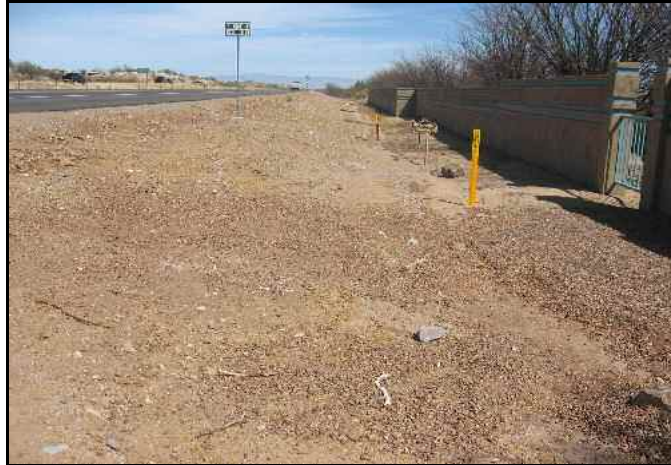
**Comp #:** 1016 Granite (Park #16) - Replenish

Evaluation: Park #16 is currently dirt. The association plans to install granite at this area during 2011 for approximately \$5,000. The initial install cost is considered a capital improvement and not a Reserve expense. Funding has been provided for future replenishing.

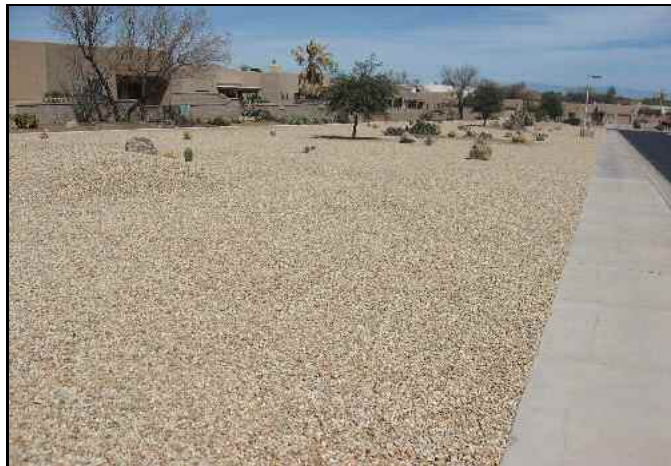
**Comp #:** 1017 Granite (Park #17) - Replenish

Evaluation: The association installed granite in these areas around 2005 for \$9,550. Observed to be full and in good shape. This component provides funding to top dress the existing landscape granite with a new 1" layer.

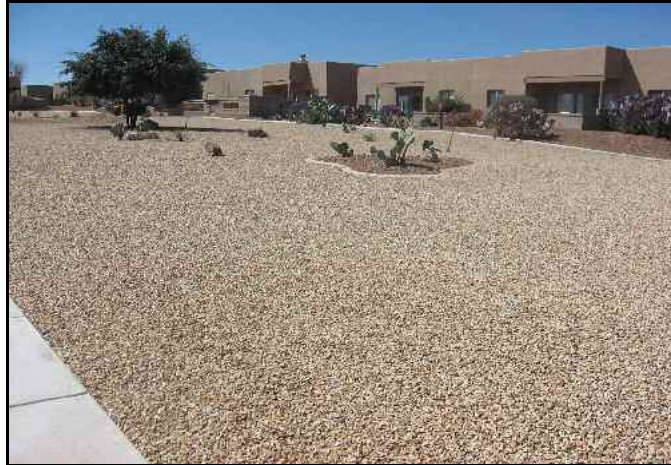
**Comp #:** 1018 Granite (Park #18) - Replenish

Evaluation: The association installed granite in these areas around 2005 for \$7,800. Observed to be full and in good shape. This component provides funding to top dress the existing landscape granite with a new 1" layer.

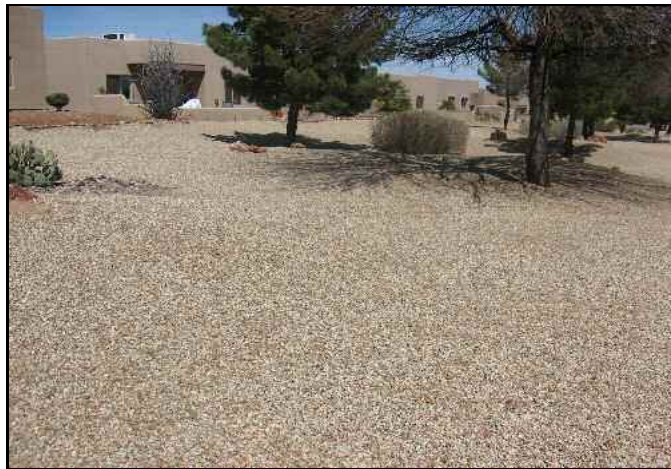
**Comp #:** 1020 Granite (Park #20) - Replenish

Evaluation: Approximately \$9,800 has been spent in the last few years to replenish Park #20. Surfaces are generally full with good coverage. This component provides funding to top dress the existing landscape granite with a new 1" layer.

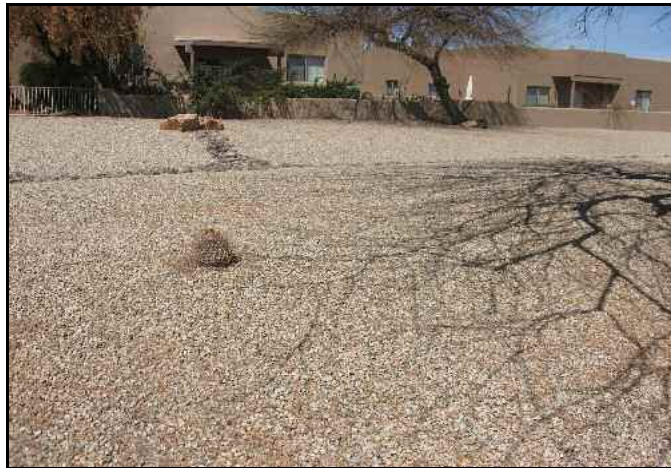
**Comp #:** 1021 Granite (Park #21) - Replenish

Evaluation: Approximately \$6,300 has been spent in the past few years to replenish Park #21. Still in good shape. Surfaces are full with good coverage. This component provides funding to top dress the existing landscape granite with a new 1" layer.

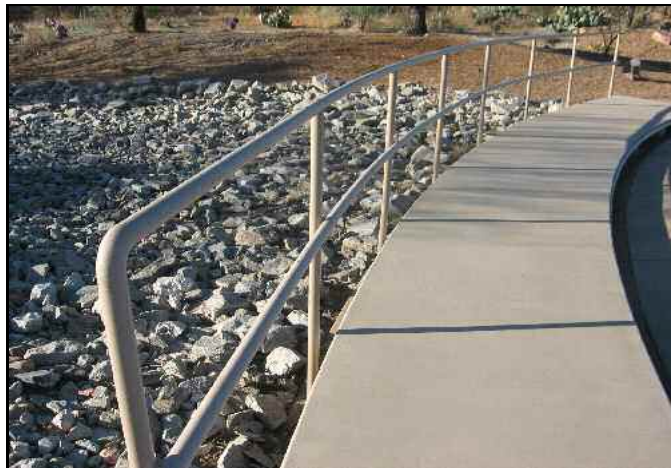
**Comp #:** 1022 Granite (Park #22) - Replenish

Evaluation: The association added rip rap and a small amount of granite in these areas around 2007 for approximately \$3,500. Only a small portion of Park #22 has landscape granite. No issues noted.

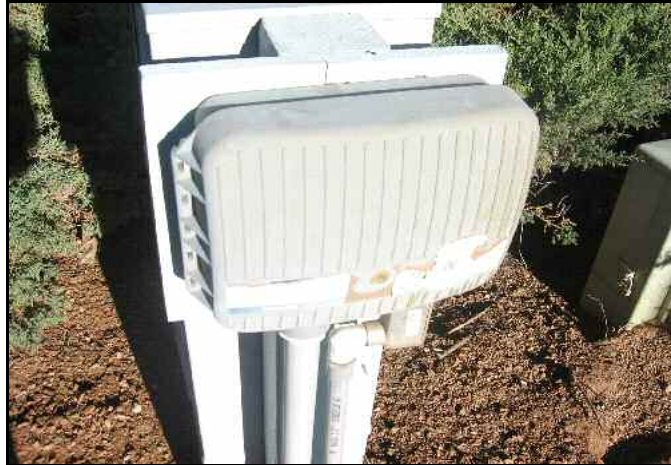
**Comp #:** 1030 Irrigation Controllers - Replace

Evaluation: These are relatively inexpensive controllers that should be replaced individually as needed as an Operating expense. No Reserve funding required.

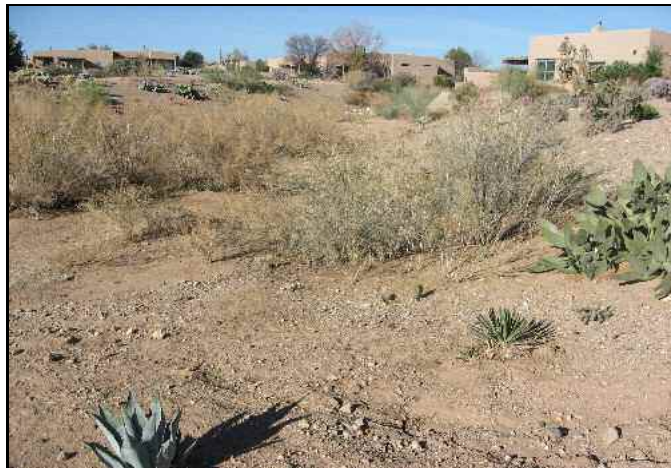
**Comp #:** 1040 Wash - Clean Out

Evaluation: The association periodically cleans out the washes to remove debris buildup. This allows water runoff to move through the washes without flooding. Some smaller work will be done during 2011 as an Operating expense. The association expects a more thorough clean out during 2012 as a Reserve expense.
