Client: 12303B The Springs - Parks + Landscape

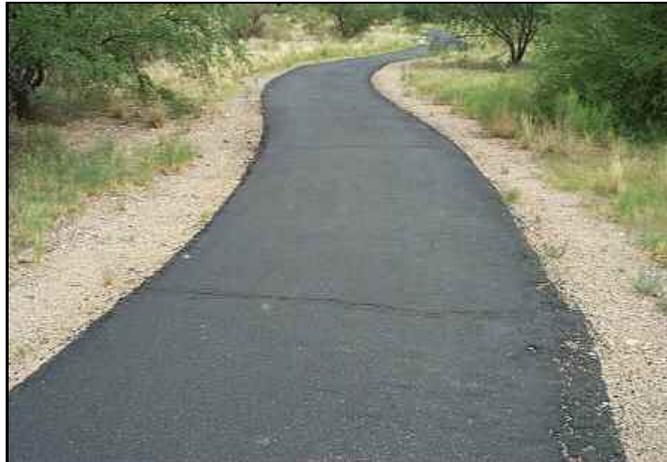
Comp #: 202 Asphalt Path - Replace (1996)

Evaluation: This asphalt walking path was installed during 1996. Still in overall good condition. Some cracking noted. Some of the edges are becoming eroded and deteriorated. At the association's request, no funding has been allocated for replacement. Paths will be maintained and repaired with the streets, but not replaced.

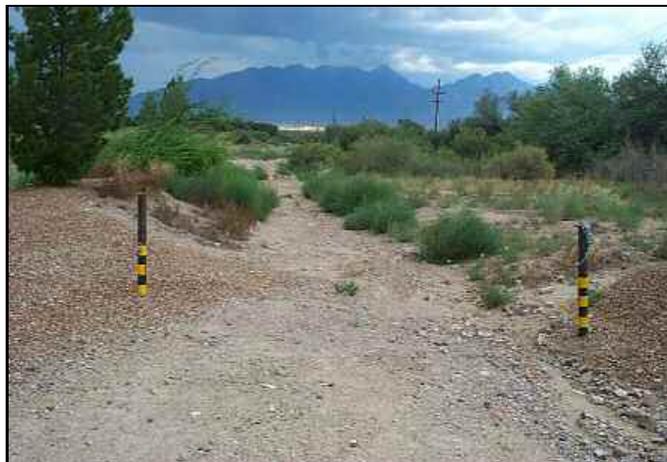
Comp #: 202 Asphalt Path - Replace (2005)

Evaluation: The existing walking trail will be extended to Wolf Run Rd. during 2005. Cost to install this trail will be split by the developer and association. Initial expense is a capital improvement, not a Reserve expense. At the association's request, no funding has been allocated for future replacement. Paths will be maintained and repaired with the streets, but not replaced.

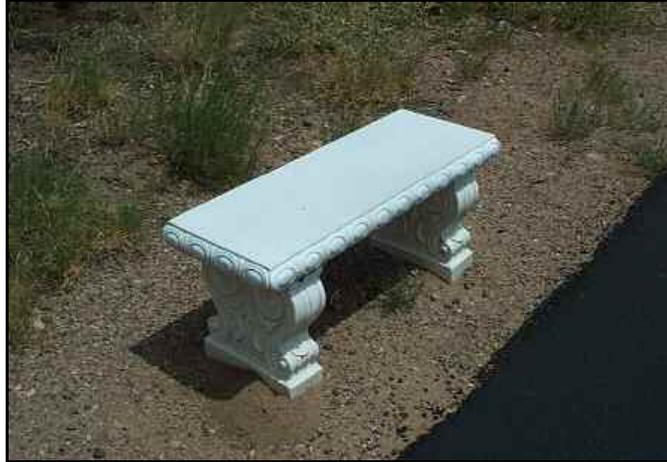
Comp #: 404 Concrete Benches - Replace

Evaluation: Benches were recently installed. Good conditions observed. There is no expectancy to replace all of them at the same time in the future. The association plans to replace them individually as needed.

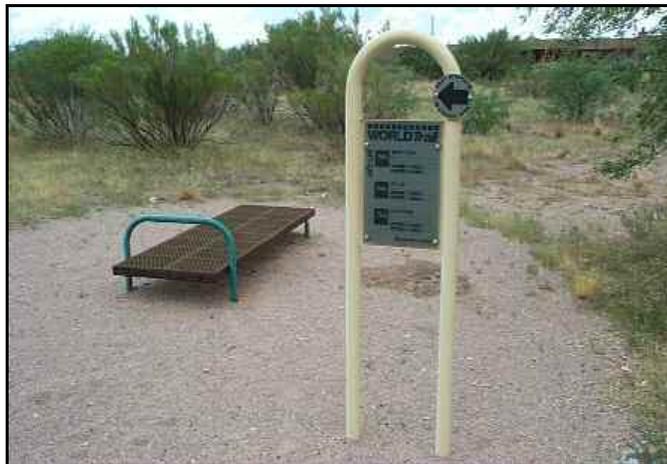
Comp #: 410 Fitness Trail - Replace (The Park)

Evaluation: Stations include introduction & warm up, body curl, step up, horizontal ladder, inclined body curl, heart check, beam jump, push up, leg lift, chin up, and cool down. Equipment was installed around 1996. Long life expectancy under normal circumstances. 30-year life span assigned at association's request.

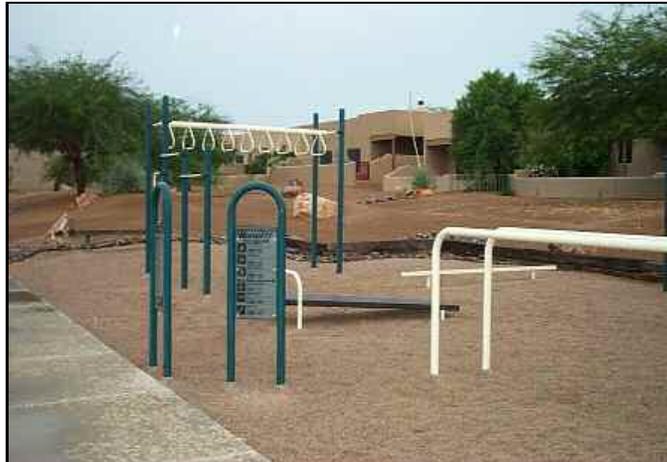
Comp #: 411 Fitness Trail - Replace (Park #21)

Evaluation: Trail set-up is very similar to The Park. It is just condensed into a smaller area. Equipment was installed around 1996 and still appears to be in good condition. Long life expectancy under normal circumstances. Replacement should be anticipated long before failure occurs. 30-year life span assigned at association's request.

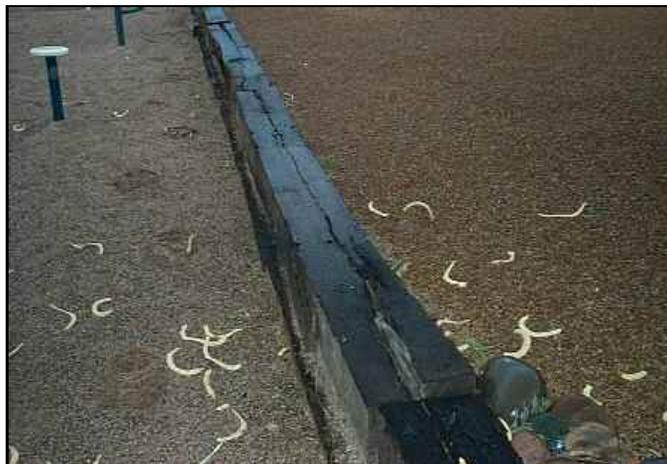
Comp #: 412 Wood Timbers - Replace

Evaluation: These wood timbers are original from 1996. They look old. Many are split and cracked. Anticipate replacing them eventually.

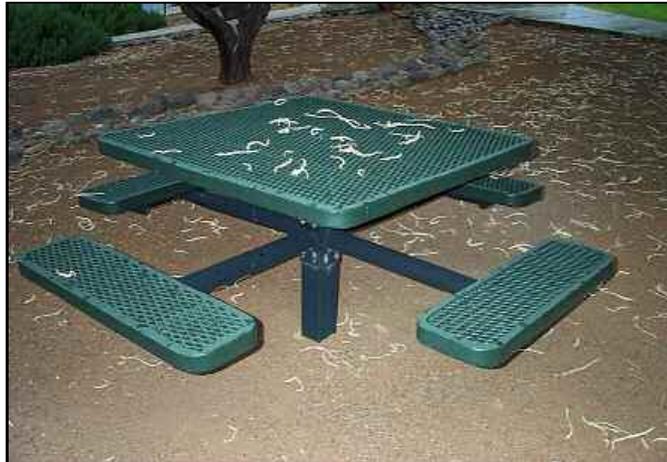
Comp #: 420 Park Furniture - Replace

Evaluation: Furniture consists of (6) 46" square picnic tables with 4-attached seats, (2) 6' picnic tables, and (4) 8' benches. All pieces are expanded metal with a plastic coating. Original from 1996. Still intact and in good shape. 30-year life span assigned at association's request.

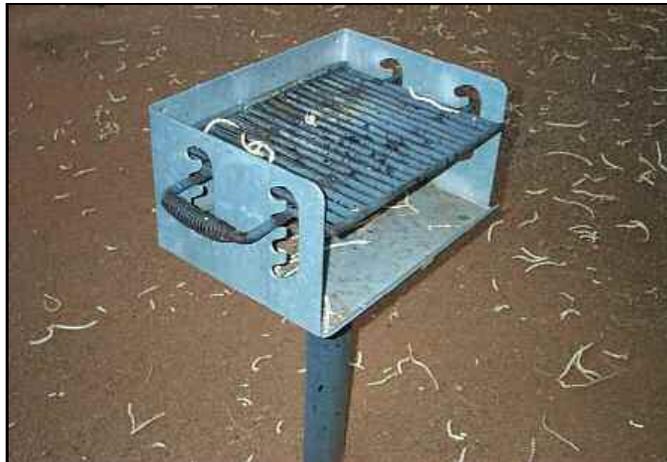
Comp #: 422 BBQ Grills - Replace

Evaluation: This park has both a standard size and double size charcoal grill. They are original from 1996 and look older. Still in decent shape due to minimal use. The association plans to remove rather than replace the grills in the future, so no Reserve funding has been allocated.

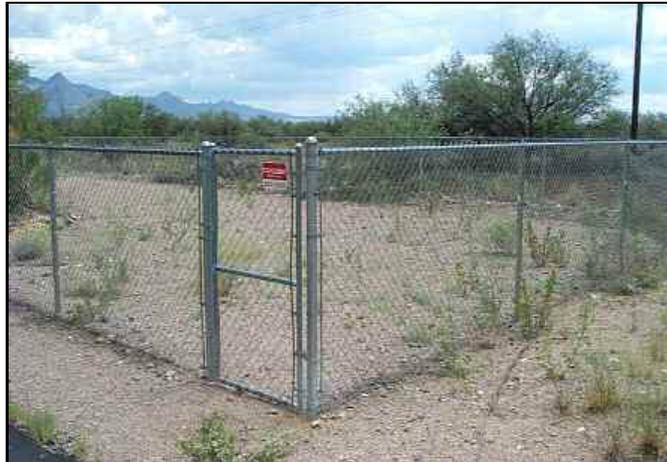
Comp #: 502 Chain Link Fence - Replace

Evaluation: The chain link fence enclosure is used for a dog area. This is galvanized chain link. It appears to be in good condition. No signs of damage or abuse noted. There is no expectancy to completely replace. Recommend repairing or replacing sections of it as needed.

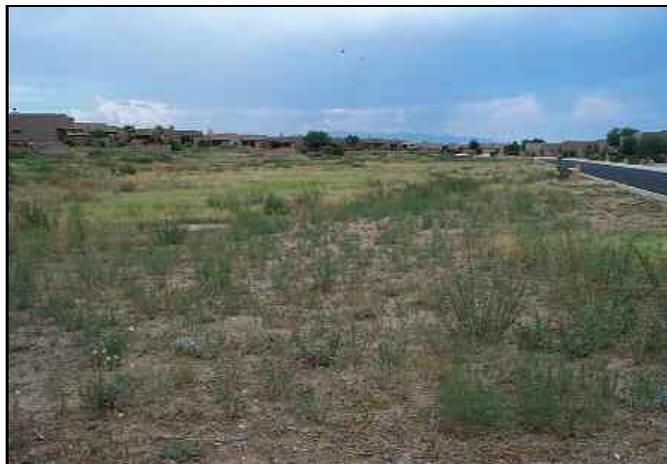
Comp #: 1002 Granite (Park #2) - Replenish

Evaluation: Desert park #2 area consists of natural landscape and vegetation. The association expressed interest in upgrading this area with granite and desert scape. This would be a capital improvement to the community, not a Reserve issue. Renovation of this area will be addressed separate from Reserves, if ever done.

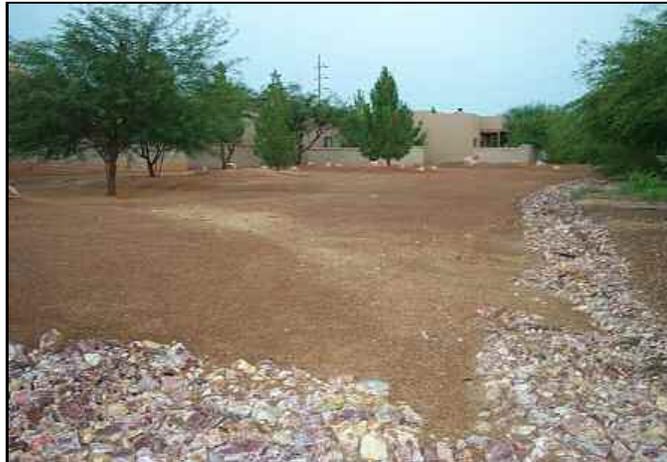
Comp #: 1004 Granite (Park #4) - Replenish

Evaluation: Desert park #4 is primarily behind homes. This component provides an allowance to periodically replenish the granite surfaces visible from the street. The granite in this area is likely original from 2000 with Phase 2 of the community.

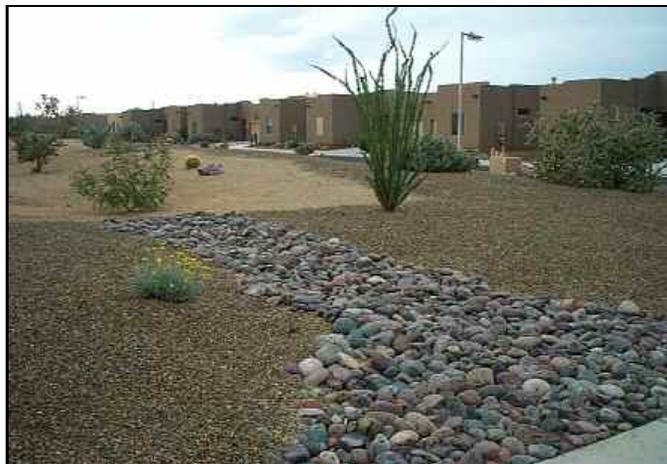
Comp #: 1006 Granite (Park #6) - Replenish

Evaluation: Park #6 is approximately 43,200 square feet. Approximately 60% of this area was replenished around 2003 for \$8,000. The section not replenished is hardly visible from the street. Not a priority to finish this area. Visible sections bordering the street look new and attractive.

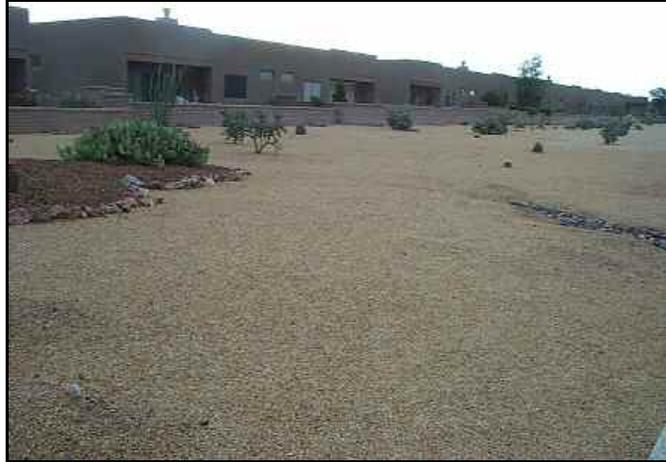
Comp #: 1007 Granite (Park #7) - Replenish

Evaluation: Park #7 is approximately 47,100 square feet. It looks well covered. Sections with contrasting colors appear to be newer. This section has had some work. Replenishing this area is not a priority right now.

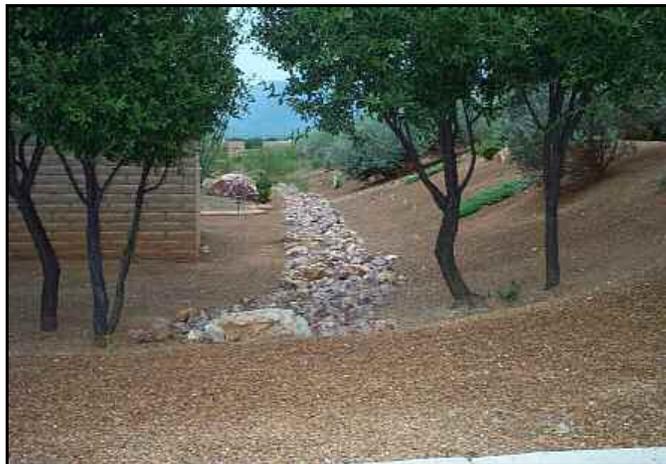
Comp #: 1008 Granite (Park #8) - Replenish

Evaluation: Most of this area is hidden from the street. It looks like the edges may have been replenished already. Most of this tract should be original from 2000. Park #8 is approximately 50,738 square feet. We estimate it will take approximately 290 tons of granite to top dress with a new 1" layer.

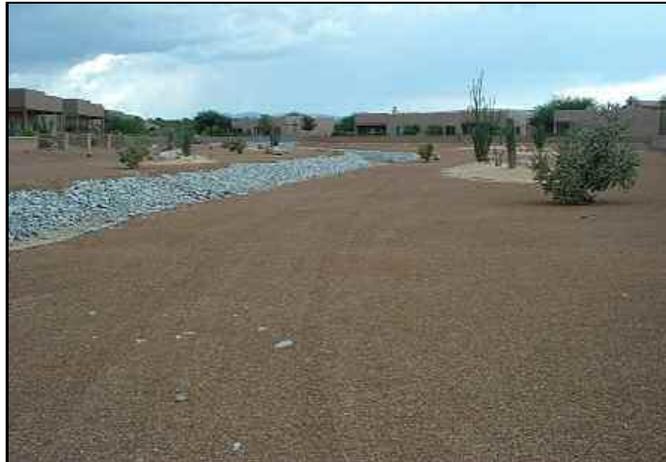
Comp #: 1009 Granite (Park #9) - Replenish

Evaluation: This area with a wash running down the middle. The minus sized granite in this area tends to deplete fast. Expect to replenish with larger rock in the future. Rock should be original from 2000. Area is approximately 112,723 square feet. We estimate it will take approximately 515 tons of granite to top dress with a new 1" layer.

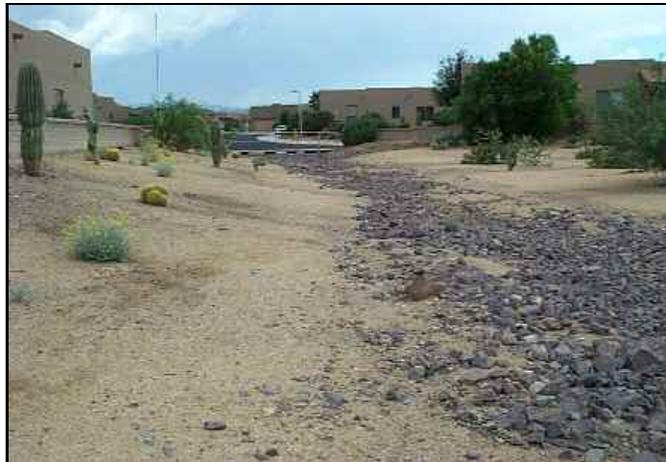
Comp #: 1010 Granite (Park #10) - Replenish

Evaluation: Park areas #10 and 11 are essentially the same location. We have split them in half to ease the funding. Park #10 looks more worn and deteriorated than 11. Recommend planning to refurbish this section in the near future. The total of 10 and 11 is 1,233,648 square feet. Allocation is only for higher visibility sections.

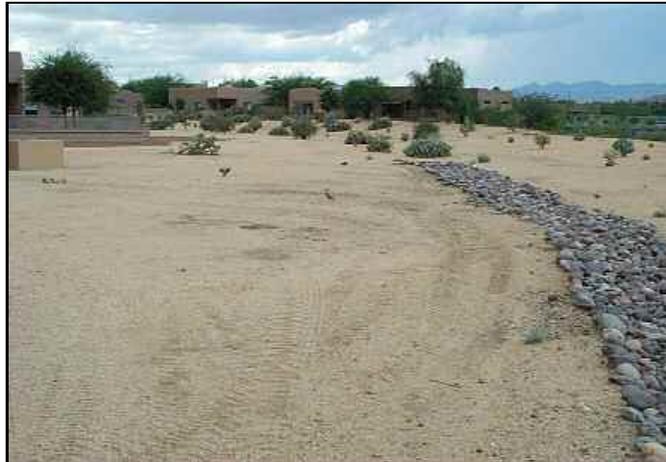
Comp #: 1011 Granite (Park #11) - Replenish

Evaluation: Parks #10 and 11 are essentially the same location. We have split them in half to ease the funding. Park #11 has already been replenished along portions of the perimeter. The total of 10 and 11 is 1,233,648 square feet. Allocation is only for higher visibility sections.

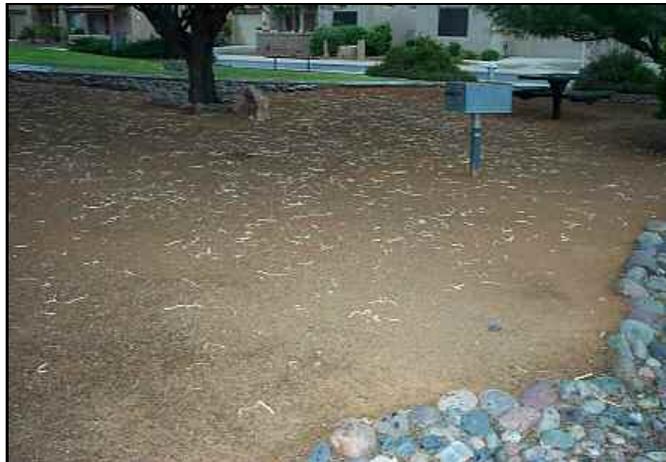
Comp #: 1013 Granite (Park #13) - Replenish

Evaluation: Park #13 is approximately 24,750 square feet. It is a mixture of grass and rock areas. We estimate approximately half of the area consists of rock. Granite surfaces are practically bare dirt. This is the worst park in the community, and it should be first priority for replenishing.

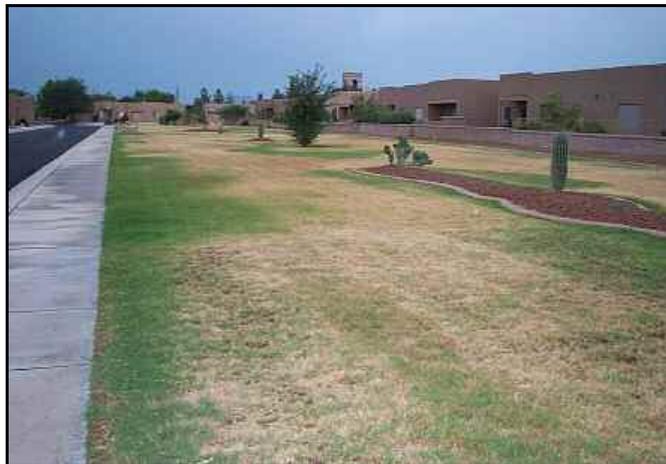
Comp #: 1015 Granite (Park #15) - Replenish

Evaluation: Park #15 is a grass area. The association expressed interest in converting this park to granite. This would be a capital improvement to the community, not a Reserve issue. Renovation of this area will be addressed separate from Reserves, if ever done.

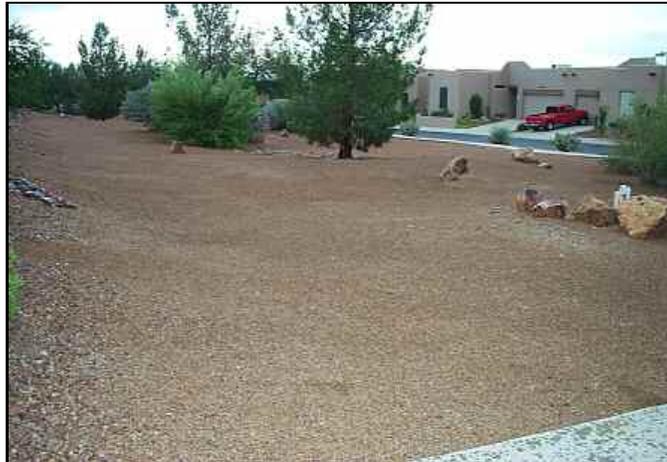
Comp #: 1020 Granite (Park #20) - Replenish

Evaluation: Park #20 is approximately 40,000 square feet. Granite covering is original from 1996. It currently has minus granite. Surfaces getting thin and dirt becoming visible. Recommend upgrading to larger rock for a longer lasting, improved appearance.

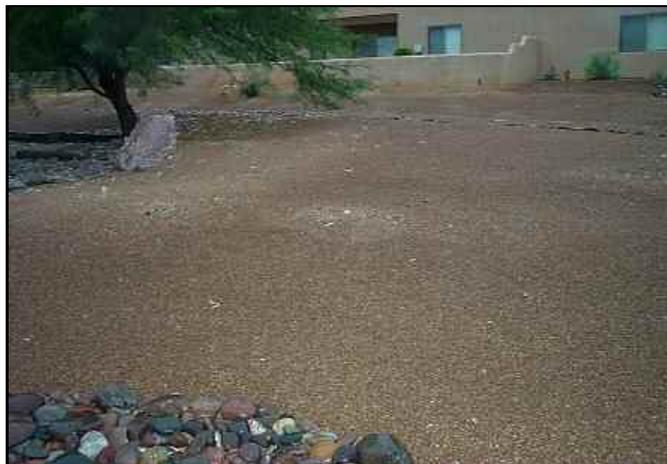
Comp #: 1021 Granite (Park #21) - Replenish

Evaluation: Park #21 is approximately 32,700 square feet. Granite covering is original from 1996. It currently has minus granite. Looking old and thin. Recommend upgrading to larger rock for a longer lasting, improved appearance.

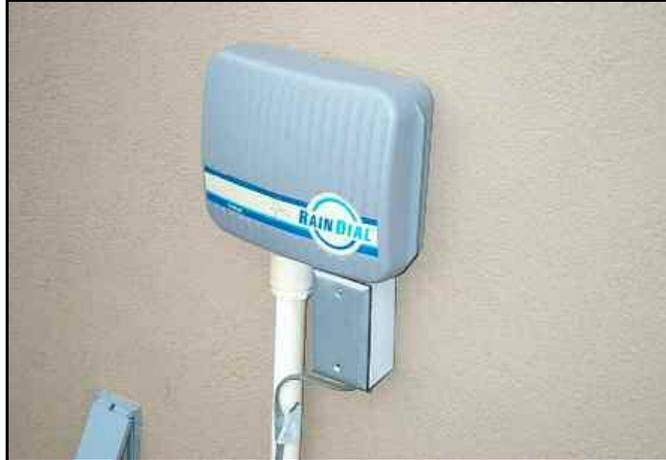
Comp #: 1030 Irrigation Controllers - Replace

Evaluation: Many of the controllers are no longer in use. Some do not work. These are relatively inexpensive units that should be replaced individually as needed. No Reserve funding required at this time.
