Client: 12303A The Springs - Common Area

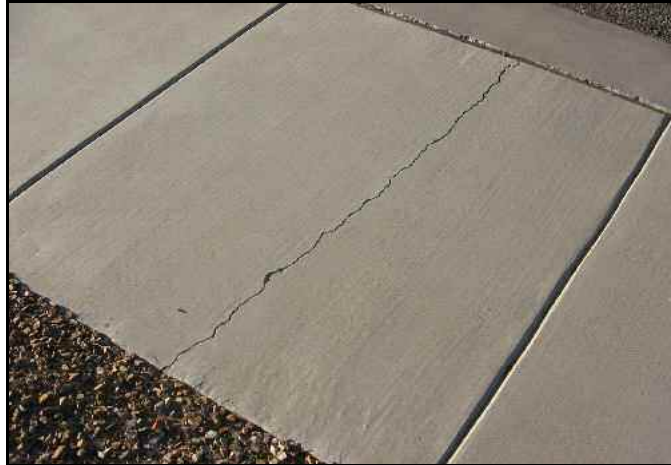
Comp #: 103 Concrete - Repair

Evaluation: There is no expectancy to completely replace the concrete. Periodic repairs should be anticipated. Overall good conditions observed. Some cracks still noted. The association plans to treat repairs as an Operating expense.

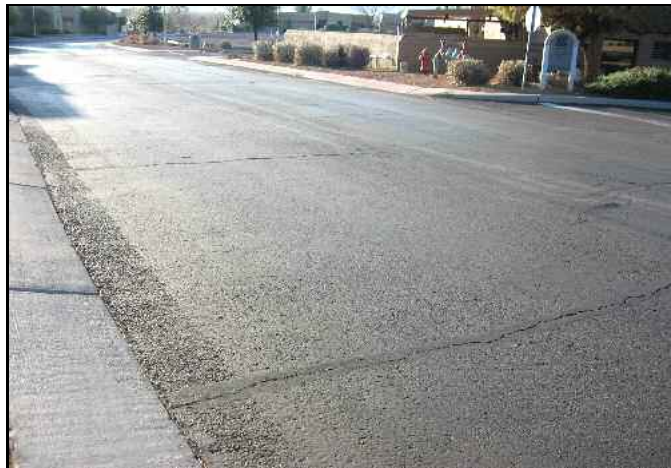
Comp #: 201 Asphalt - Resurface

Evaluation: Streets were installed during 1996-2000. Some issues with the base have been reported. Moderate amount of larger cracks and some alligating noted. It is likely that some streets will require a complete remove and repave, while others will only need an overlay. Useful life assumes periodic patch work will be done.

\$1.40/Sq Ft; Estimate for combination of overlay and remove and repave

\$1.80/Sq Ft; Higher estimate for complete remove and repave

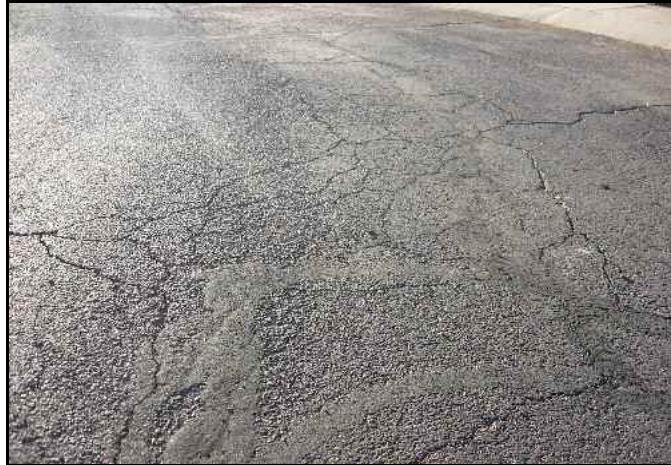
Comp #: 204 Asphalt - Patch/Repair

Evaluation: The asphalt is failing in some areas. Alligatoring and larger cracks evident. Expect to remove and repave these areas rather than an overlay, to ensure the base is repaired if needed. The association received a bid during 2010 of \$22,253 to repave failing areas. Repairs should be anticipated during 2011.

\$1.75/Sq Ft; Estimate to remove and repave 2% of the total

\$2.25/Sq Ft; Higher estimate to remove and repave 2% of the total

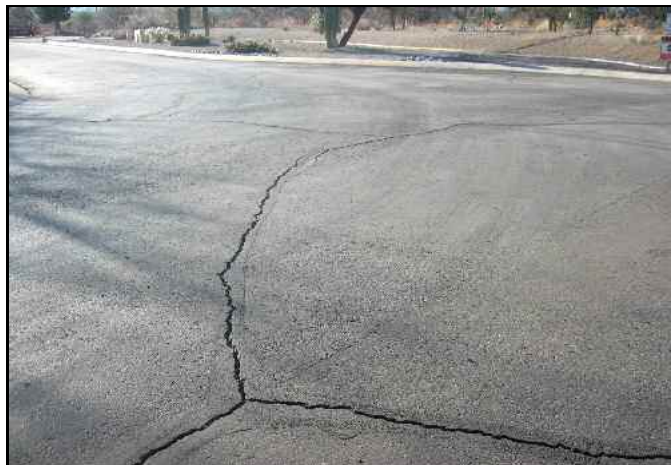
Comp #: 206 Asphalt - Crack Fill

Evaluation: Streets were crack filled during 2007 for \$22,100. The association plans to crack fill separate from seal coating the streets. The association received bids during 2010 ranging from \$14,200-\$31,900 depending on whether the gaps between the concrete and asphalt are included.

\$0.035/Sq Ft; Estimate to crack fill

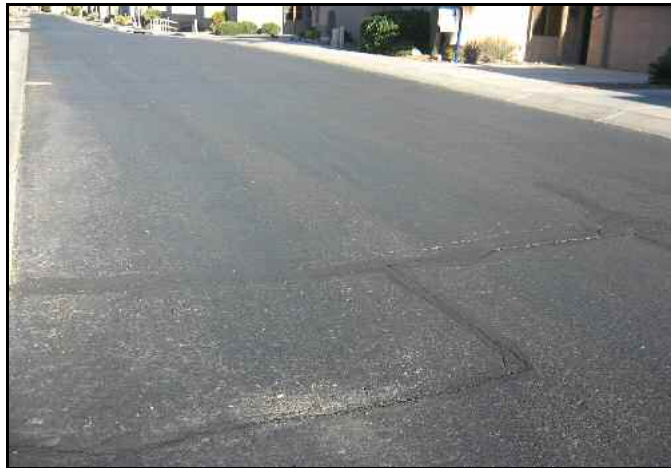
Comp #: 208 Asphalt - Seal/Repair

Evaluation: The asphalt was last sealed during 2008 for \$35,500. Still in fair condition. Seal is wearing thin along the edges adjacent to the curbs. Seal coating is not scheduled to occur until after crack filling is completed. Seal coat asphalt surfaces periodically to prevent premature cracking and deterioration.

\$0.065/Sq Ft; Estimate to seal coat

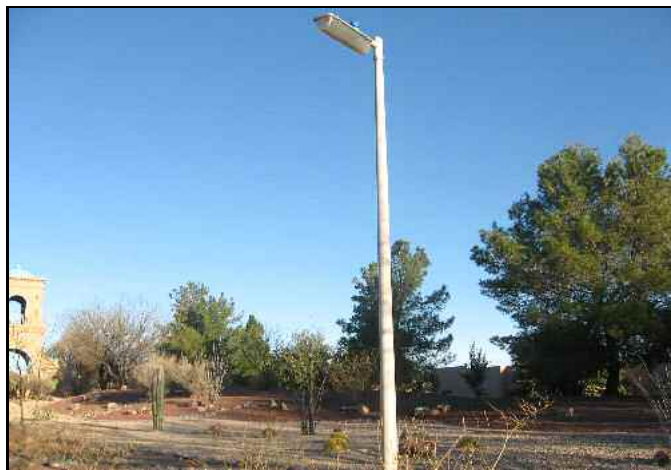
Comp #: 320 Street Lights - Replace

Evaluation: Street lights are leased through the power company. The association is not responsible to repair or replace them. No Reserve funding required.

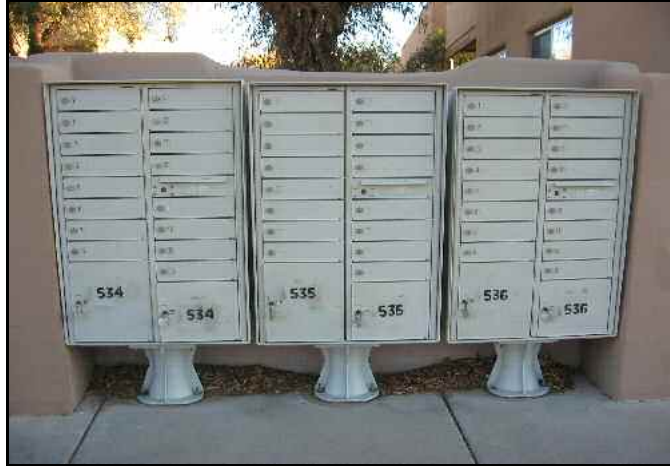
Comp #: 403 Mailboxes - Replace

Evaluation: Mailboxes are owned and maintained by the Post Office, not the association. No Reserve funding required.

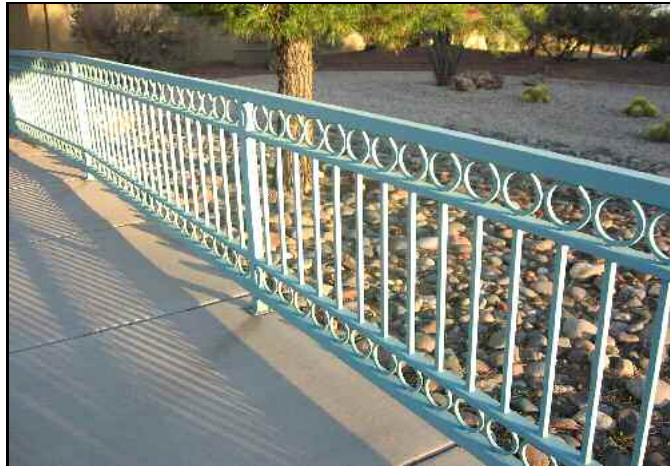
Comp #: 503 Metal Fences - Replace

Evaluation: Fences were installed during 1996. They appear to receive minimal moisture exposure. Observed to be stable and secure. No issues with rust noted. Long life component, however future replacement should still be anticipated. Repainting is included under component #1107 - Metal Fences.

Best Case: \$5,500.00
\$25.00/LF; Estimate to replace

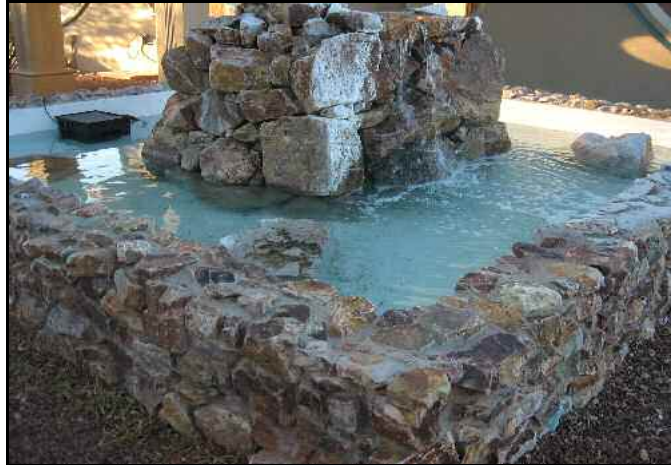
Comp #: 600 **Fountain Bed - Resurface**

Evaluation: This is a concrete fountain with a white painted surface. There is no expectancy for complete replacement of the concrete. Treat repairs and repainting the surface as an Operating expense. The decorative stone exterior should also be repaired when needed as an Operating expense.

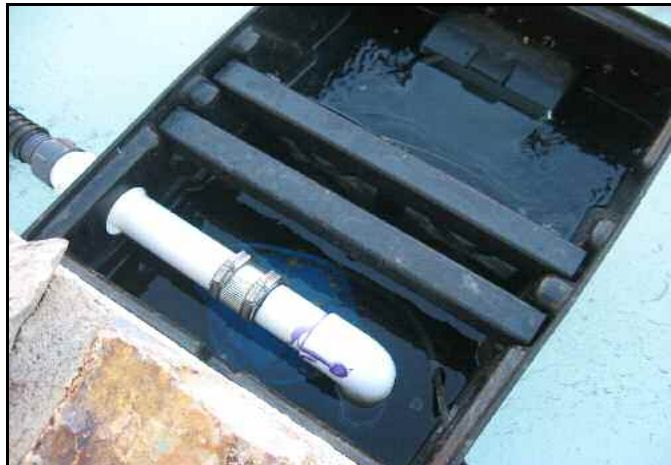
Comp #: 601 **Fountain Pump - Replace**

Evaluation: Pump was reportedly installed during 2011. Actual cost is not clear. Cost may have been around \$600, with either labor or parts donated. Pump is submerged with limited access to inspect. Appears functional with no reported problems. Model: W-1408-11.

Best Case: \$800.00
Estimate to replace

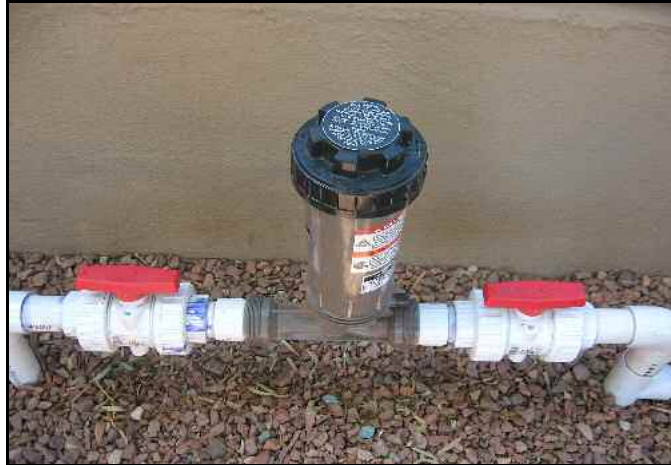
Comp #: 602 Fountain Chlorine Feeder - Replace

Evaluation: Feeder was installed during 2011. Appears functional with no reported problems. Replacement cost is too small for Reserve designation. Replace when needed as an Operating expense.

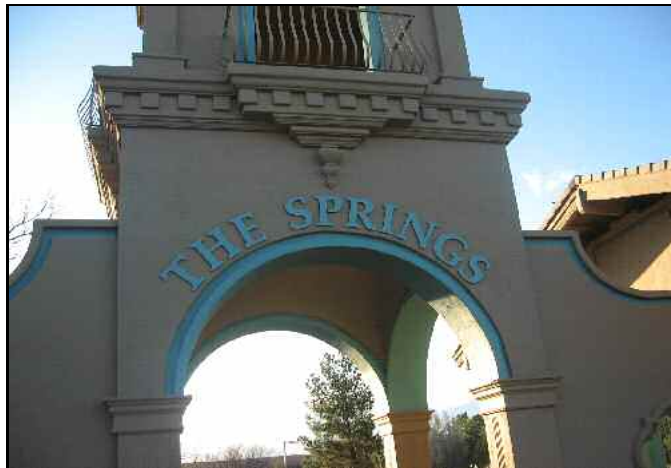
Comp #: 610 Monument - Refurbish

Evaluation: Monument has (10) stamped, steel letters with a patina finish. They are securely attached and still in good condition. The letters typically will not wear out, but we normally recommend replacement to update or modernize the appearance. No Reserve funding has been allocated as previously requested by the association.

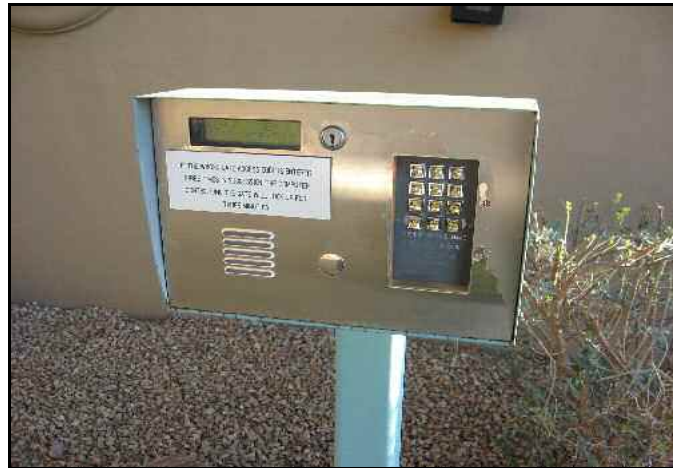
Comp #: 703 Entry System - Replace

Evaluation: System is original from 1996. Older and worn. The association has a warranty agreement which covers full replacement, except for vandalism or theft. However, the warranty can be canceled by either party with a 30 day written notice. It would still be prudent for the association to build Reserve funds towards the entry system.

Best Case: \$4,200.00
Estimate to replace

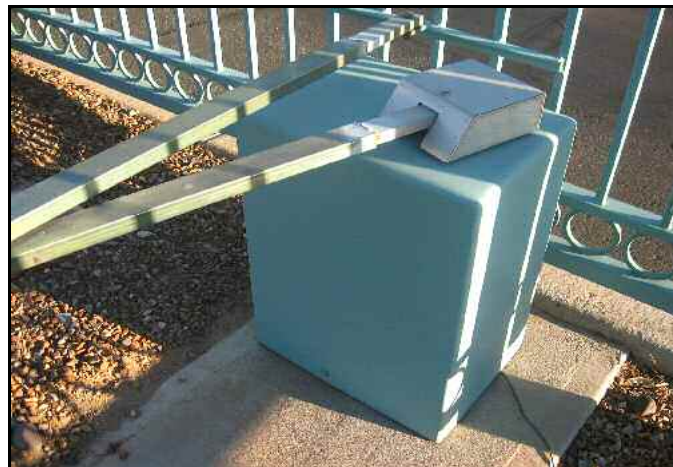
Comp #: 705 Gate Operators - Replace

Evaluation: Original from 1996. Gates are left open all day, so operators receive limited use. Many parts have been repaired or replaced. The association has a warranty agreement which covers full replacement, except for vandalism or theft. It would still be prudent for the association to build Reserve funds towards the operators.

Best Case: \$6,600.00
\$3,300/Operator; Estimate to replace

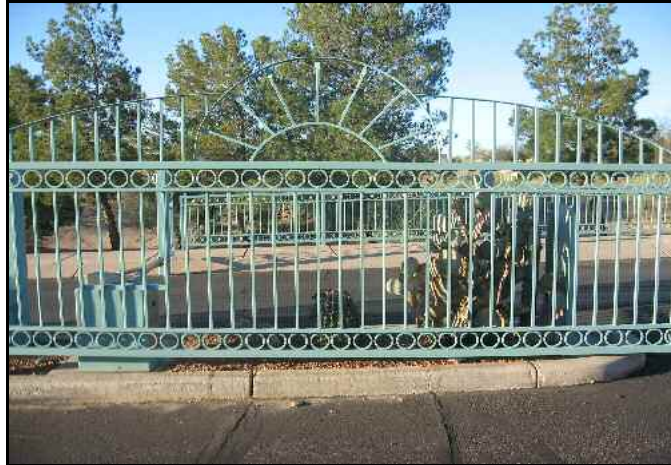
Comp #: 708 **Vehicle Gates - Replace**

Evaluation: Gates are original from 1996. They are still in good shape with no damages noted. There is no expectancy to replace the gates under normal circumstances. Replacement resulting from vehicle damage should be addressed as an insurance issue. Repainting is included under component #1107 - Metal Fences.

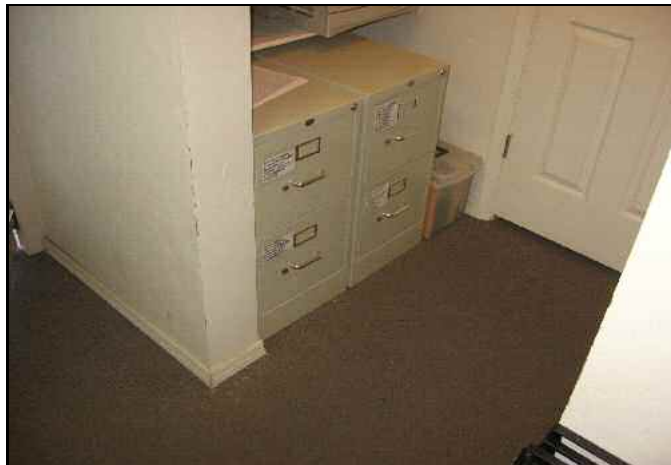
Comp #: 910 **Gatehouse - Refurbish**

Evaluation: The gatehouse interior was repainted and new carpet was installed during 2000. Paint is chipping and scuff marks evident. Carpet is still in fair shape. This is not a manned gatehouse, so it receives minimal use. No Reserve funding has been allocated to refurbish the gatehouse interior, as previously requested by the association.

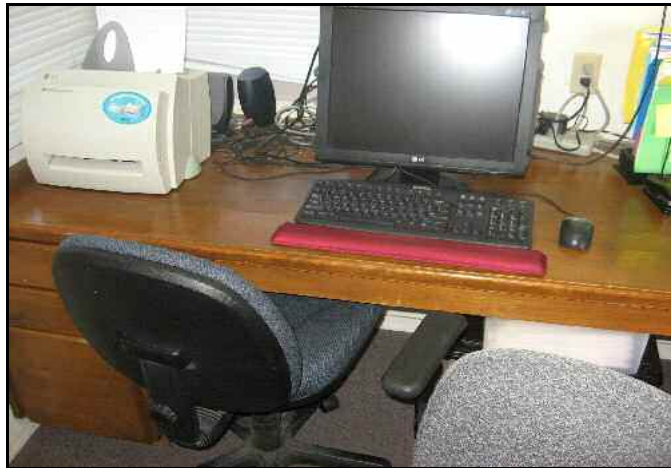
Comp #: 911 Gatehouse - Remodel

Evaluation: For a complete remodel of the gatehouse interior, replacement of the built in desk and miniblinds should be anticipated. As previously requested by the association, no Reserve funding has been allocated. Future replacement of these items will be expensed with Operating funds when needed.

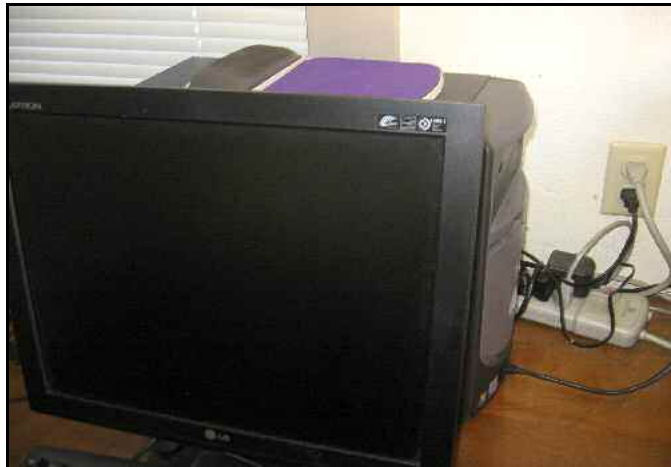
Comp #: 912 Gatehouse Computer - Replace

Evaluation: Computer was purchased during 2004 for approximately \$1,500. Some upgrades have been done since then, including more memory and a new screen. Computer prices have dropped since 2004. Replacement cost will vary depending on the amount of software upgrades required. Model: Dimension 4500.

Best Case: \$900.00
Estimate to replace

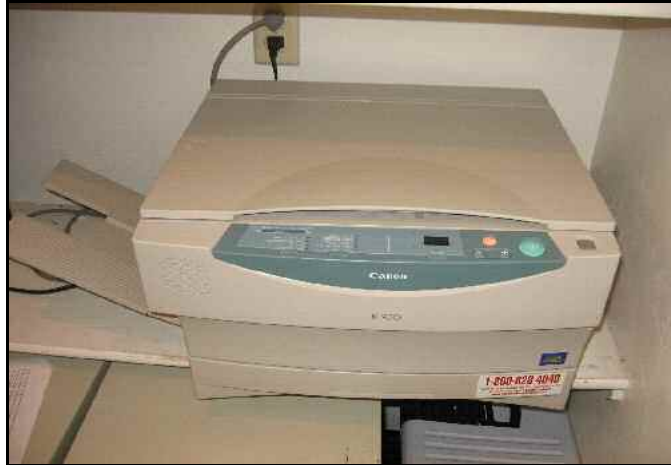
Comp #: 913 Gatehouse Copier - Replace

Evaluation: Copier was reportedly purchased around 2000. Appears to receive limited use. The association may purchase a fax/copier combination when replacement eventually occurs. No problems reported at this time.

Best Case: \$600.00
Estimate to replace

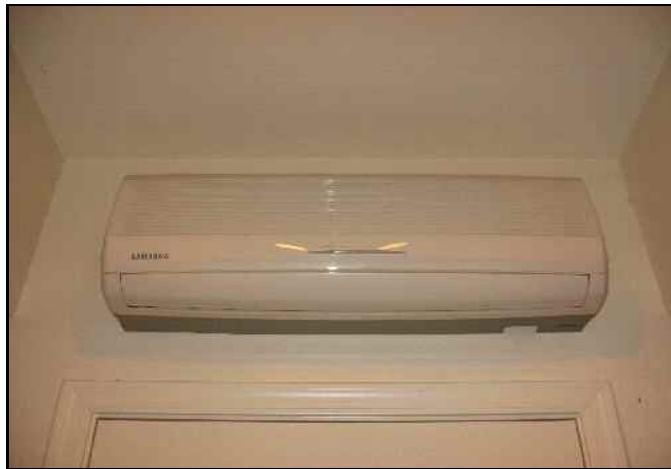
Comp #: 920 Gatehouse HVAC - Replace

Evaluation: System was installed during 2000. Appears functional with no reported problems. Unit receives minimal use. Future replacement should still be anticipated.

Best Case: \$2,000.00
Estimate to replace

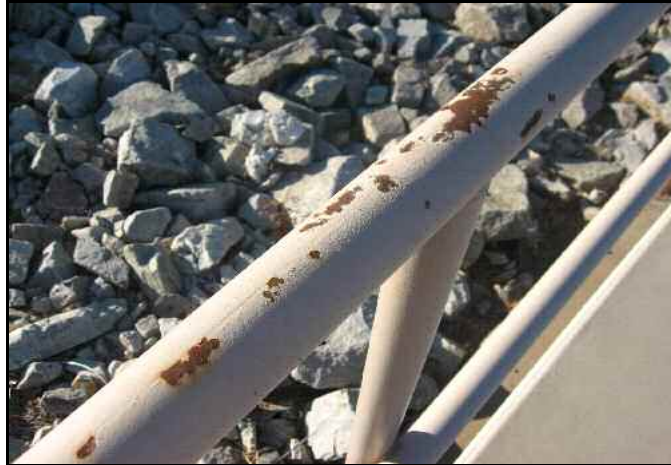
Comp #: 1106 Metal Rails - Repaint

Evaluation: Rails are repainted as-needed as an Operating expense. Some areas are in need of repainting, with chipping and rust evident. No Reserve funding has been allocated for repainting.

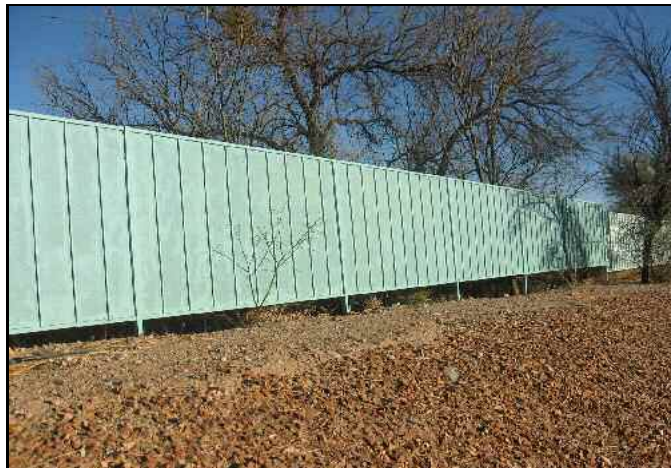
Comp #: 1107 Metal Fences - Repaint

Evaluation: This component provides funding to repaint the metal fence under component #503, along with the vehicle gates. Surfaces appear generally uniform and in good shape. Likely repainted during 2010. Repaint periodically to maintain the appearance and to inhibit rust.

Best Case: \$1,350.00
Estimate to repaint

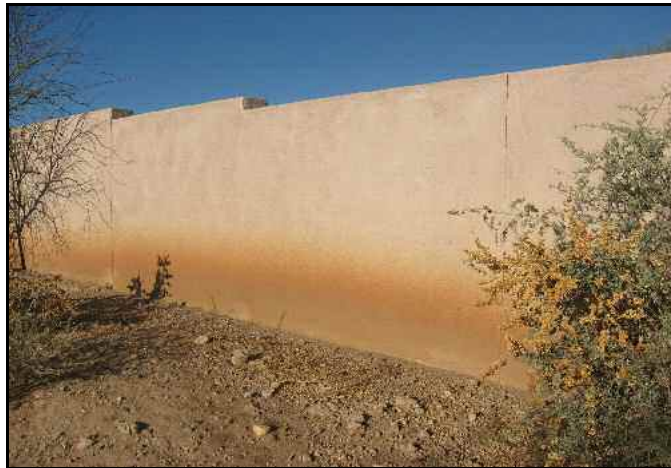
Comp #: 1113 Stucco Walls - Repaint

Evaluation: These walls appears to be in poor shape. Surfaces are severely stained, especially at the base. Recommend planning to repaint in the near future, not only to restore the appearance, but also to seal and protect the wall. These walls are less visible than the gatehouse area, so repainting is expected to occur less frequently.

\$0.52/Sq Ft; Estimate to repaint

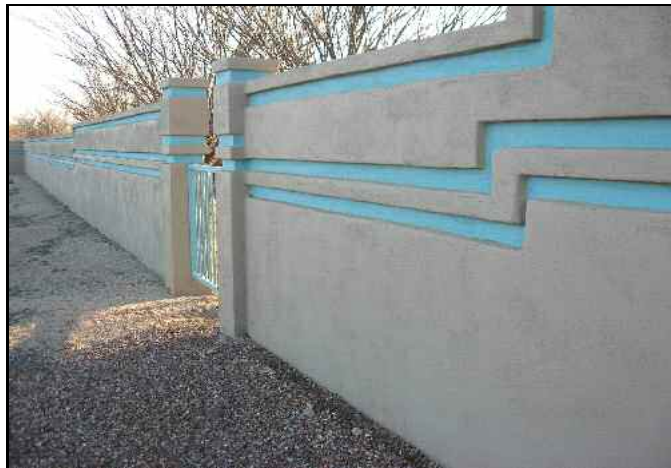
Comp #: 1113 Stucco Walls - Repaint

Evaluation: These walls were recently repainted with the gatehouse exterior. The association plans to repaint these walls with the gatehouse as one project. Repainting is included under component #1115.

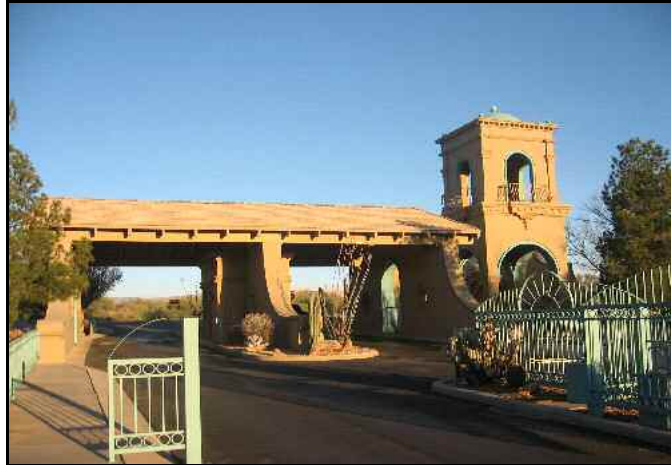
Comp #: 1115 Gatehouse Stucco Surfaces - Repaint

Evaluation: Surfaces were repainted during 2010 for approximately \$10,500. Observed to be uniform and in good condition. This is a high visibility area, so frequent repainting is expected.

Best Case: \$9,600.00
\$0.52/Sq Ft; Estimate to repaint

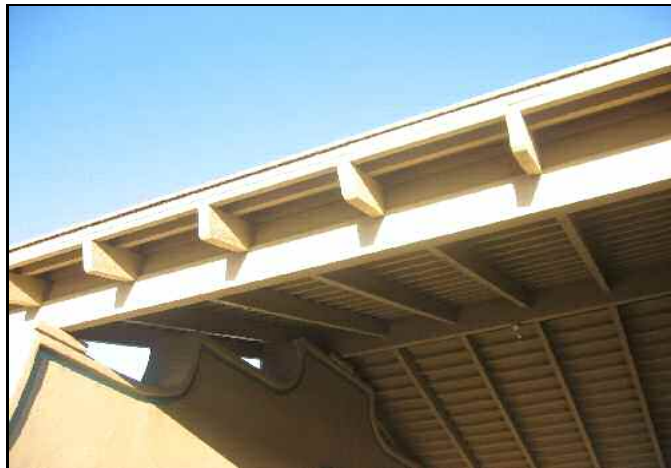
Comp #: 1116 Gatehouse Wood Surfaces - Repaint

Evaluation: Surfaces were repainted during 2010 for approximately \$1,250. Good conditions observed. Color is uniform with no discoloration noted. Recommend coordinating with repainting the gatehouse stucco surfaces if possible. Touch-ups between repainting intervals should be handled as an Operating expense.

Best Case: \$1,150.00
Estimate to repaint

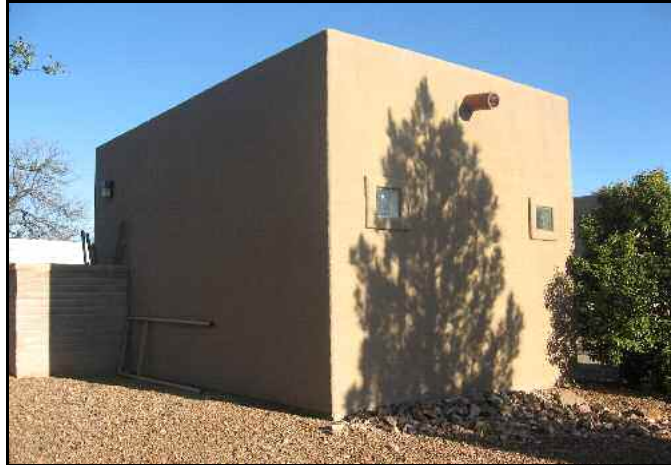
Comp #: 1120 Maintenance Building - Repaint

Evaluation: This building has a color coat surface, it is not painted. The coating will eventually fade and need to be painted. Life span reflects paint, and the remaining life span reflects the color coat surface. Surface is original from 1996, and still in good shape.

Best Case: \$550.00
\$0.60/Sq Ft; Estimate to repaint

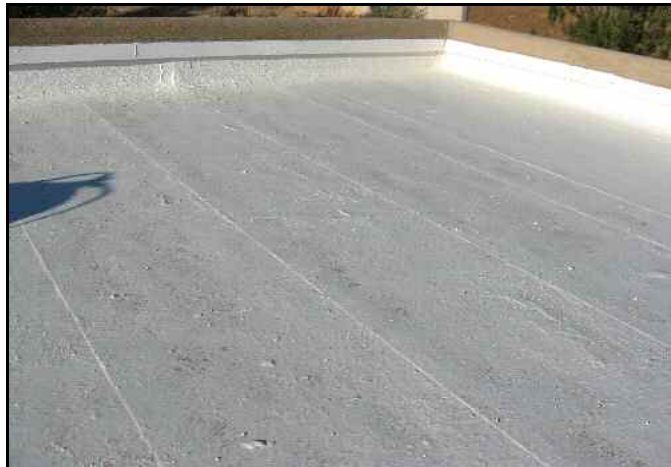
Comp #: 1301 Flat Roof - Replace

Evaluation: This building has a cap sheet roof. Original from 1996. The roof has an elastomeric coating and appears to be well maintained. Recoat the roof periodically as a maintenance expense. Future replacement should be anticipated. Roof was just recoated during 2010.

Best Case: \$960.00
\$3.50/Sq Ft; Estimate to replace

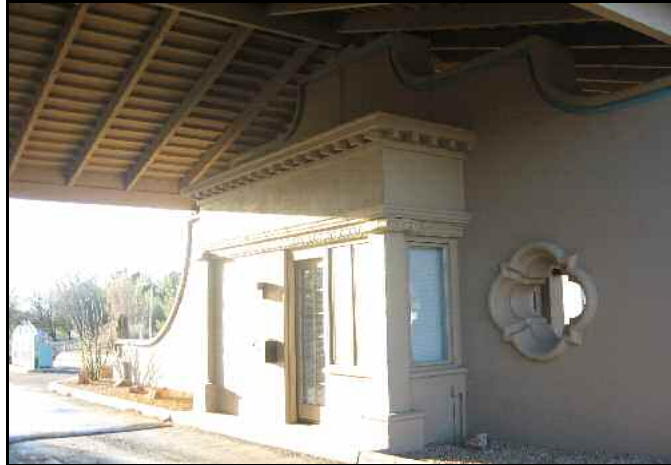
Comp #: 1302 Flat Roof - Replace

Evaluation: The office section has a small, flat roof. Original from 1996. No access to inspect. This roof is protected by the main tile roof, so it never receives sun or weather exposure. Replacement is not anticipated at this time.

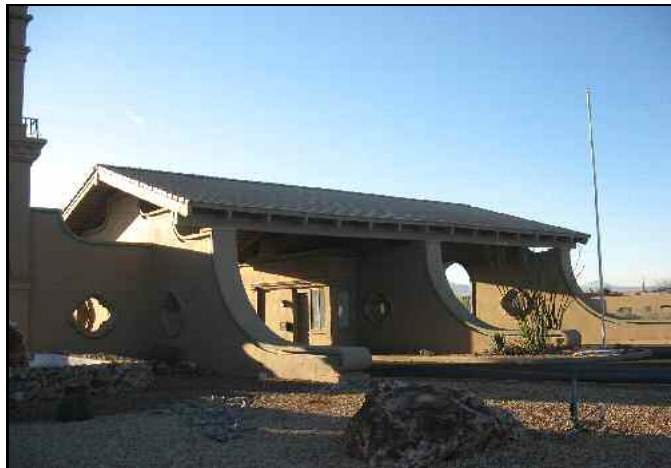
Comp #: 1304 Tile Roof - Refurbish

Evaluation: Installed during 1996. There is no expectancy to replace all of the tiles under normal circumstances. Replacement of the felt paper underlayment should be anticipated eventually. Life span will vary depending on the quality of underlayment installed. No issues observed or reported.

\$3.00/Sq Ft; Estimate to remove tiles, replace underlayment, reinstall tiles

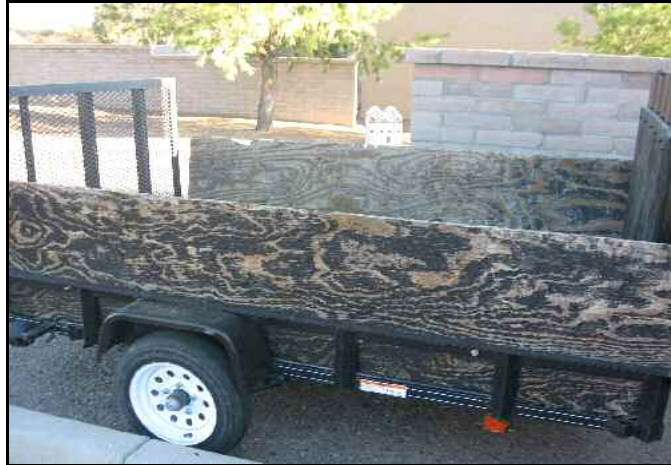
Comp #: 1500 Trailer - Replace

Evaluation: Trailer appears intact and in good shape. No signs of abuse noted. This is a single axle trailer. Long life component under normal circumstances. Future replacement should still be anticipated.

Best Case: \$500.00
Estimate to replace

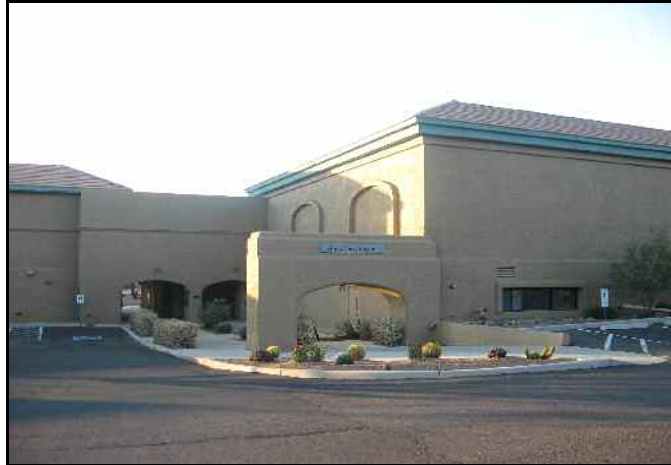
Comp #: 1600 Recreation Building

Evaluation: The Green Valley Recreation (GVR) area is maintained by a separate entity from The Springs. The Springs is not directly responsible for maintenance of this facility or parking lot.
