Client: 12303A The Springs - Common Area

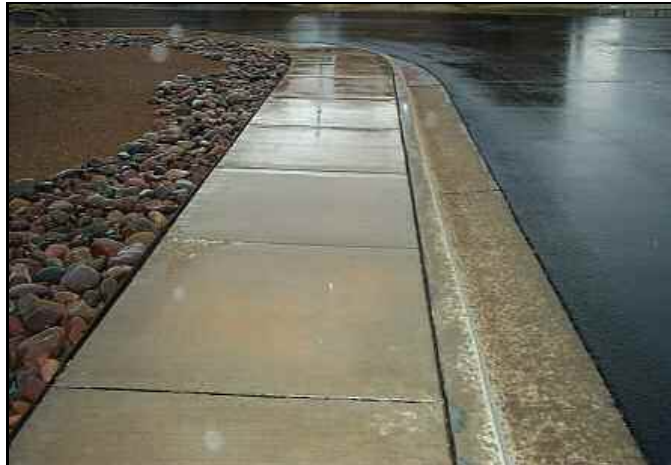
Comp #: 103 Concrete - Repair

Evaluation: The association is responsible for repairing and replacing concrete sidewalks and curbs throughout the community when needed. At the association's request, no funding has been allocated in Reserves. Repairs will be expensed through the Operating fund when needed.

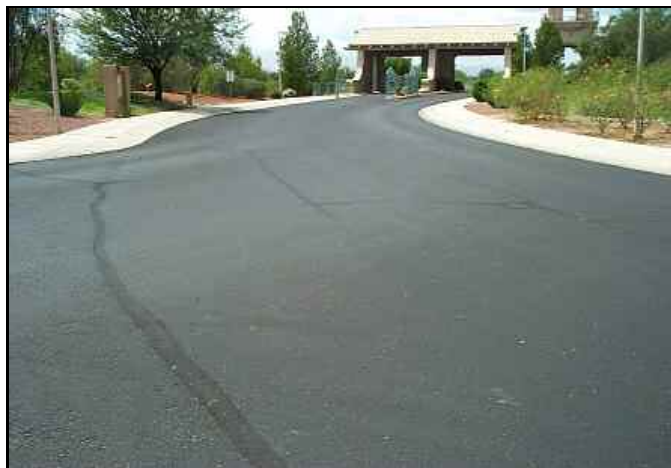
Comp #: 201 Asphalt - Resurface (Phase 1)

Evaluation: Phase 1 asphalt was reportedly installed around 1996. Surfaces are still generally smooth and in good condition. Some cracks and rough spots were noted. Seal coat periodically to protect and preserve the surface.

\$0.50/Sq Ft; New topcoat/overlay

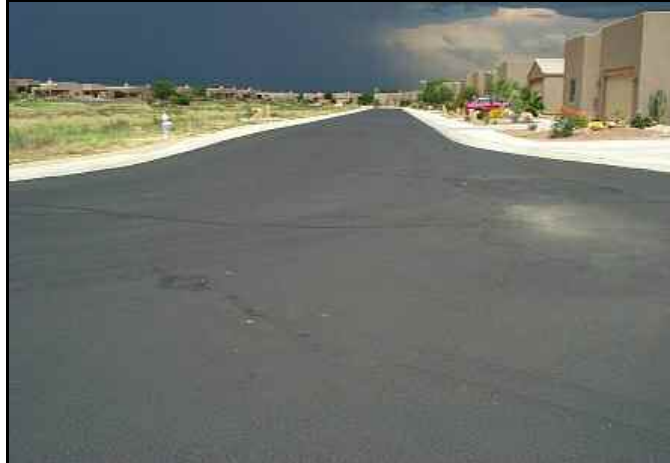
Comp #: 201 Asphalt - Resurface (Phase 2)

Evaluation: Phase 2 asphalt was reportedly installed during 2000. Some areas already exhibit a lot of cracks. Most of the roads are smooth and in good condition. Seal coat periodically to protect and preserve the surface.

Best Case: \$78,750.00
\$0.60/Sq Ft; New topcoat/overlay

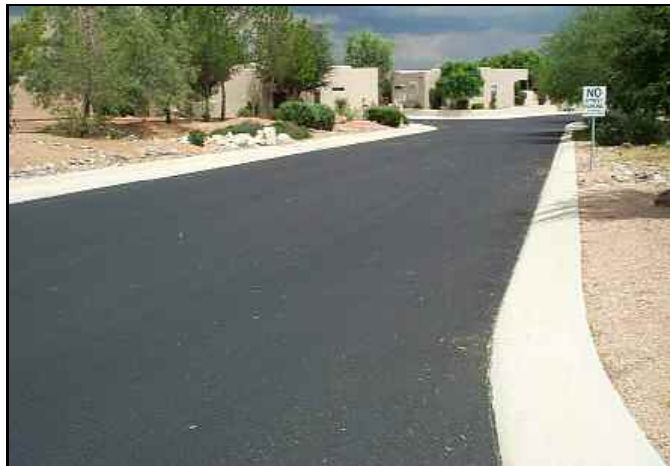
Comp #: 205 Asphalt - Seal/Repair

Evaluation: The asphalt was just seal coated during 2004 for approximately \$24,000, except the storage building driveway. Good conditions observed. Expect to reseal at least every 4 years to properly protect and maintain the surfaces.

Best Case: \$21,800.00
\$0.037/Sq Ft; Estimate to seal coat

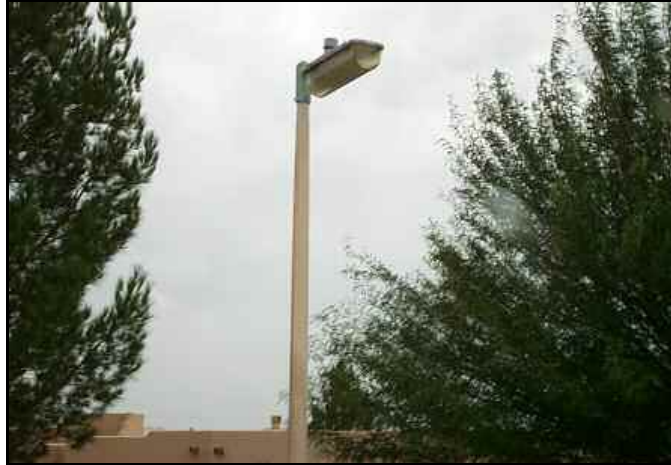
Comp #: 320 **Street Lights - Replace**

Evaluation: Street lights are leased through the power company. The association is not responsible to repair or replace them. No Reserve funding required.

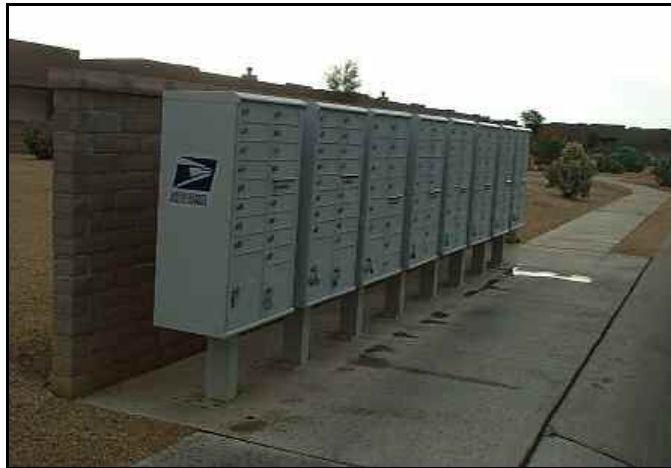
Comp #: 403 **Mailboxes - Replace**

Evaluation: Mailboxes are owned and maintained by the Post Office, not the association. No Reserve funding required.

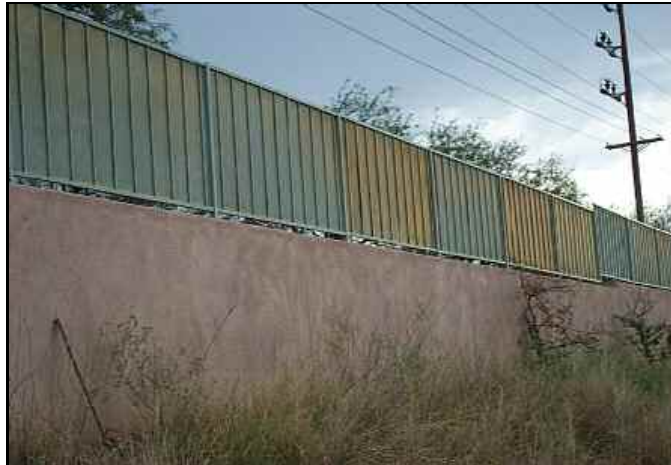
Comp #: 503 Metal Fences - Replace

Evaluation: This perimeter area has metal fencing mounted on top of the stucco walls. Most of the fence has fallen off and been removed. The remaining fence sections will be removed eventually. The association does not plan to maintain or replace them. No Reserve funding required.

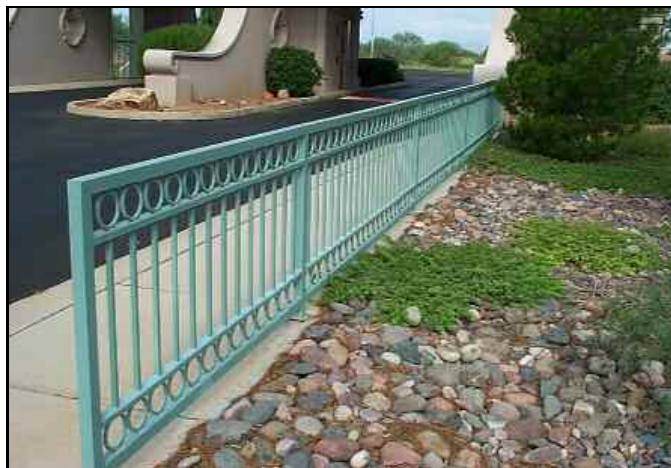
Comp #: 503 Metal Fences - Replace

Evaluation: Fences are mounted to the concrete sidewalks. No sprinkler exposure. They will still eventually rust, so the association should plan to eventually replace. Good condition at the time of inspection.

\$24.00/LF; Estimate to replace (both sides of road)

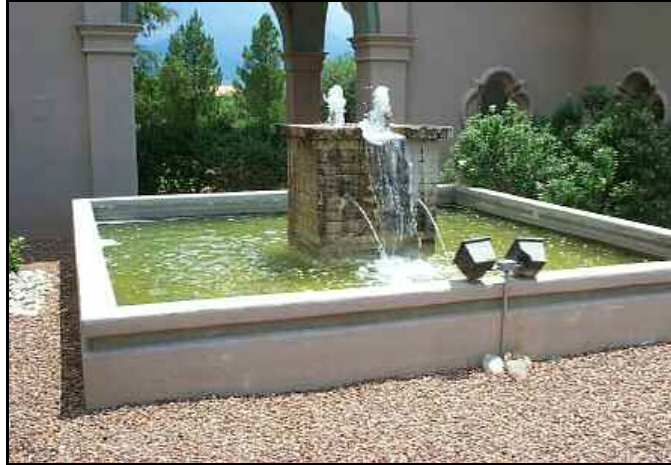
Comp #: 600 Fountain Bed - Resurface

Evaluation: This is a concrete fountain. There is no surface to replace or maintain. Periodic cleaning should be addressed as ongoing maintenance. No Reserve funding required.

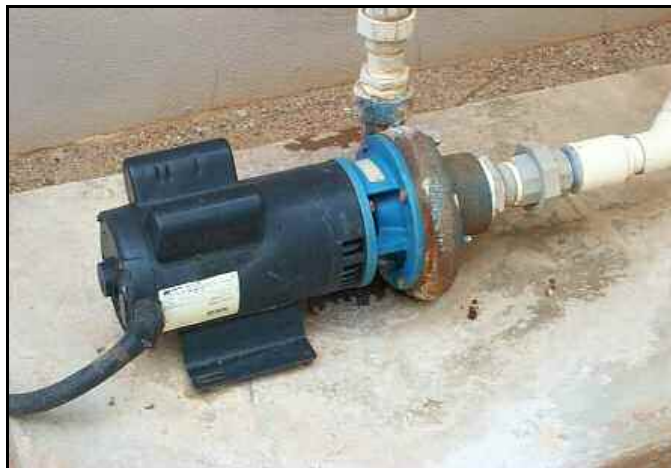
Comp #: 601 Fountain Pump - Replace

Evaluation: Pump appears to be original. Bottom has a significant amount of rusting. Some water was leaking at the time of inspection. Pump has since been repaired. Replacement should be anticipated in the near future. Pump will need to be replaced in the near future. Frame Y184JM, 3450 RPM.

Estimate to replace

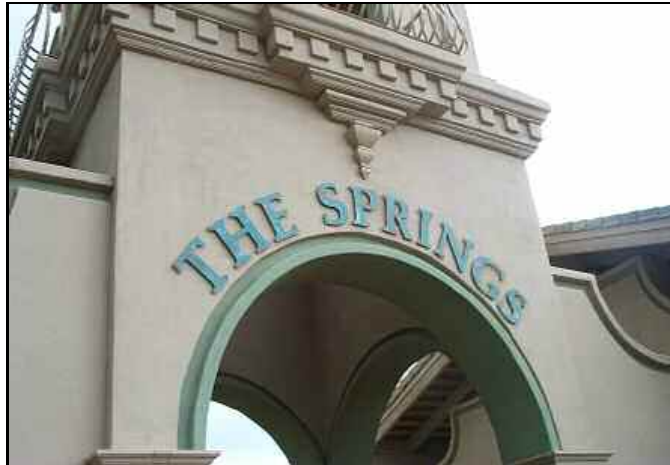
Comp #: 610 Monument - Refurbish

Evaluation: Monument has stamped, steel letters with a patina finish. They are securely attached and in good condition. Letters will not likely wear out, but future replacement is typically to change the appearance. No funding has been allocated at the association's request.

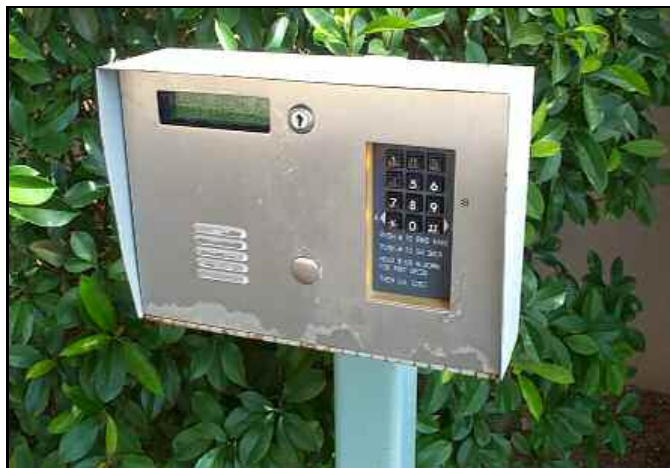
Comp #: 703 Entry System - Replace

Evaluation: Entry system is expected to be original from 1996. It is a small unit with 2-line display and recessed keypad. Minor surface wear noted, but no signs of damage or abuse. Still appears to be in good shape.

Estimate to replace

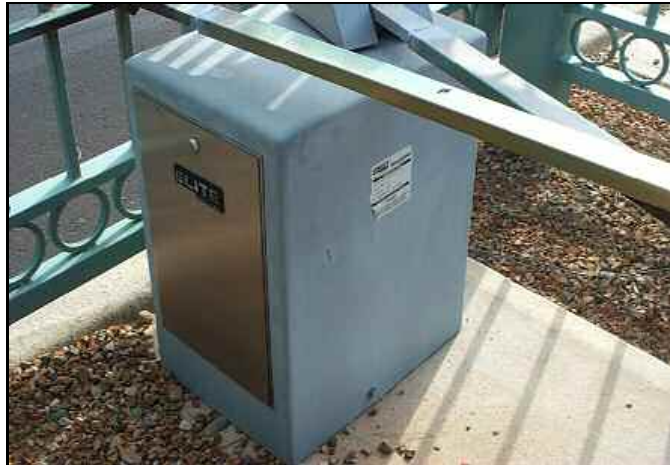
Comp #: 705 Gate Operators - Replace

Evaluation: Gate operators are still original from 1996. Gates are left open all day, so operators receive limited use. Still appear to be in good shape for their age. No problems were reported. Model CSW-200, Serial #08159628469 (entry side) & 08159628742 (exit side).

Best Case: \$6,000.00
\$3,000/Operator; Estimate to replace

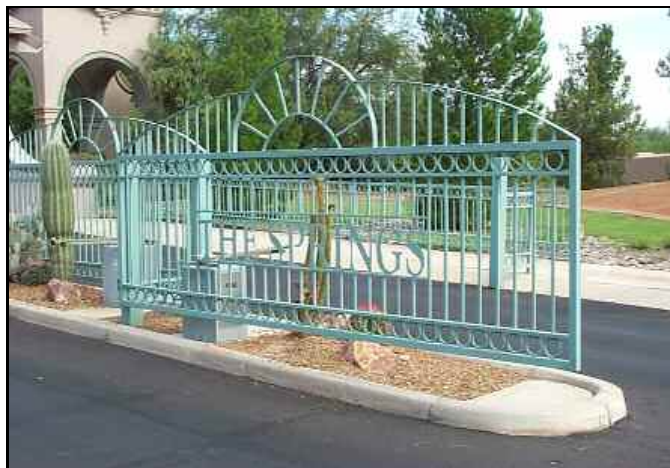
Comp #: 708 Vehicle Gates - Replace

Evaluation: Gates are original from 1996. They appear to be in good condition. There is no expectancy to replace the gates under normal circumstances. Replacement resulting from vehicle damage should be addressed as an insurance issue.

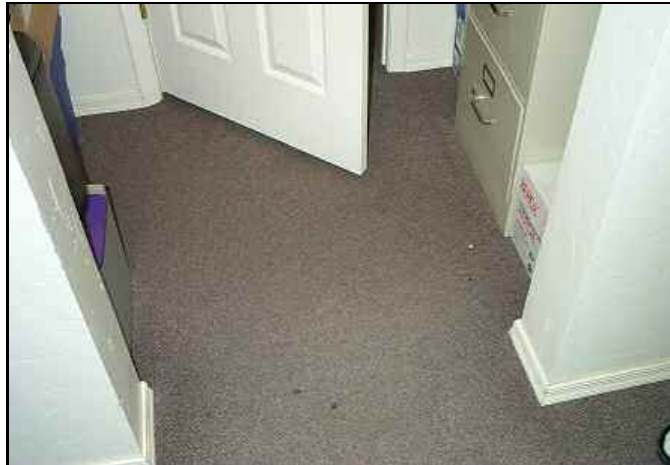
Comp #: 910 Gatehouse - Refurbish

Evaluation: The gatehouse received new carpet and paint during 2000. Some wear and minor staining noted. This is not a manned gatehouse, is only used as the association's office. No funding has been allocated at the association's request. Future carpet replacement and painting will be maintenance projects.

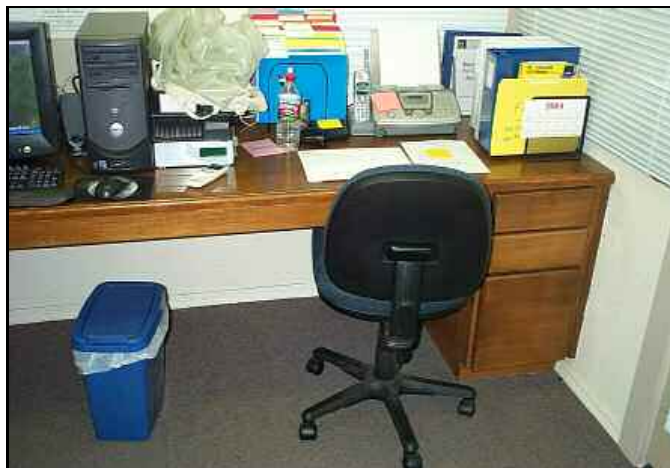
Comp #: 911 Gatehouse - Remodel

Evaluation: For a complete remodel of the gatehouse interior, replacement of the built in desk and miniblinds should be anticipated. At the association's request, no Reserve funding has been allocated. Future replacement of these items will be expensed with Operating funds when needed.

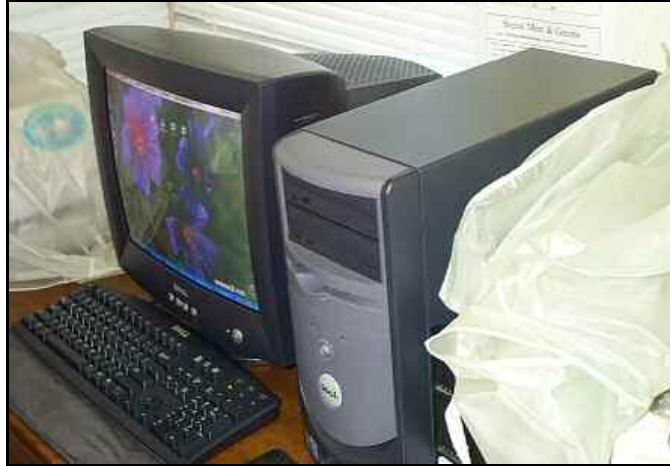
Comp #: 912 Gatehouse Computer - Replace

Evaluation: Computer was just purchased during 2004 for approximately \$1,500. New and in good condition.

Best Case: \$1,400.00
Estimate to replace

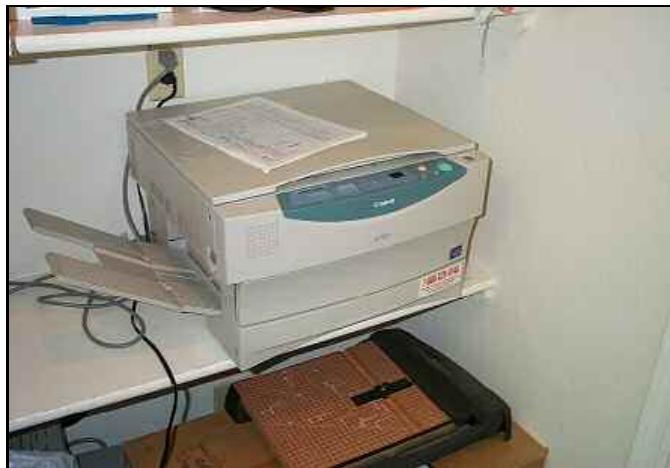
Comp #: 913 Gatehouse Copier - Replace

Evaluation: Copier was reportedly purchased around 2000. Appears to receive limited use. No problems reported.

Best Case: \$550.00
Estimate to replace

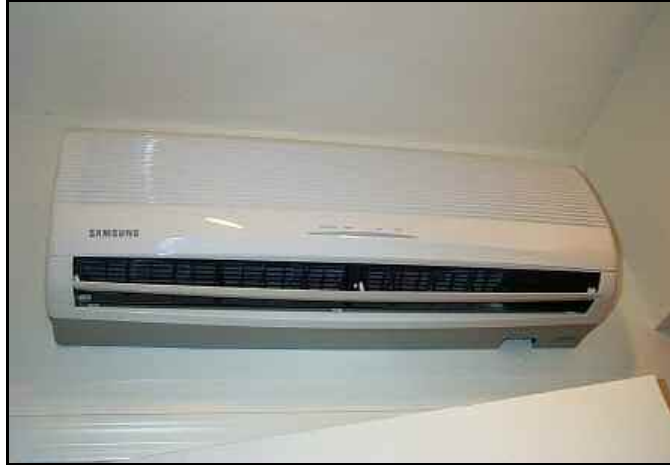
Comp #: 920 Gatehouse HVAC - Replace

Evaluation: There was no access to inspect the air conditioning system. It was reportedly last replaced during 2000. Still functional and expected to be in good to fair condition.

Best Case: \$1,800.00
Estimate to replace

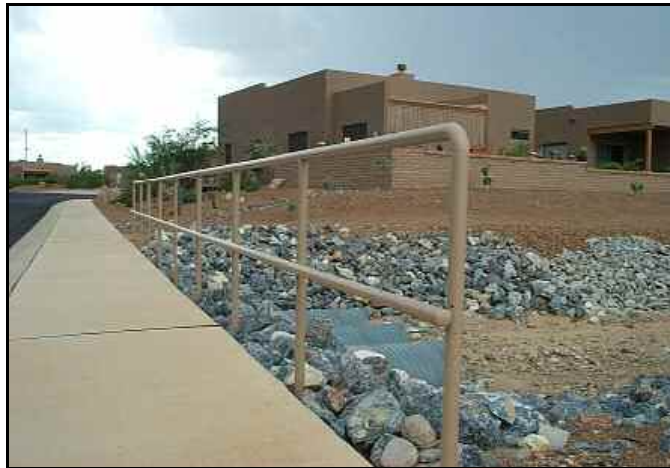
Comp #: 1106 Metal Rails - Repaint

Evaluation: Wash rails are repainted periodically as a maintenance project. No Reserve funding required.

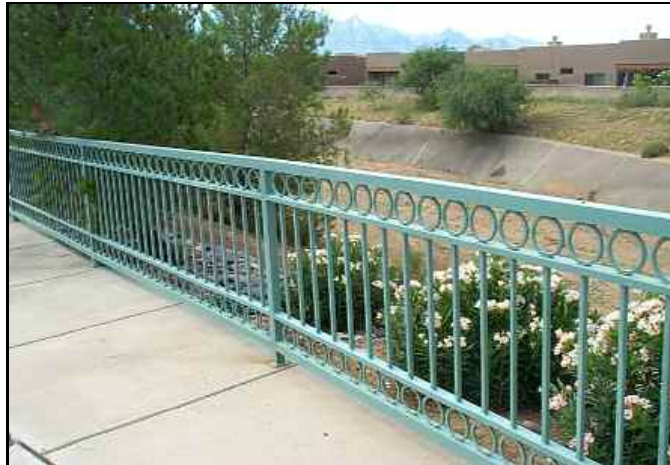
Comp #: 1107 Metal Fences - Repaint

Evaluation: The metal surfaces were last painted during 2001 with the gatehouse. The paint is not in bad shape, but it does look aged and faded already. Rust spots are also developing. Recommend planning to repaint in 2005 to protect the metal and to restore the appearance.

Best Case: \$860.00
\$5.00/LF; Estimate to repaint

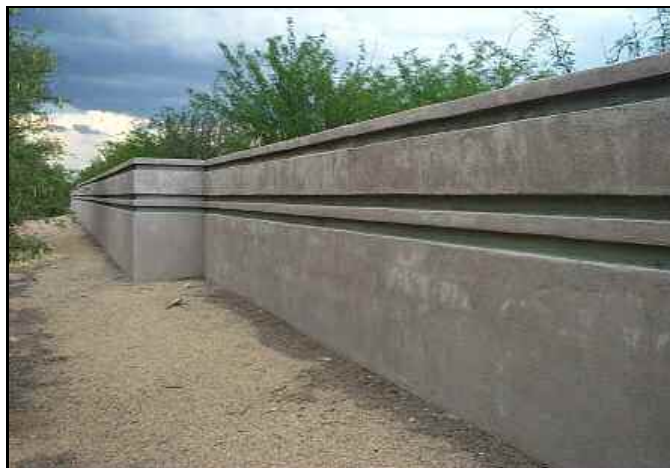
Comp #: 1113 Stucco Walls - Repaint

Evaluation: The stucco walls have never been painted. Walls bordering Frontage Road are very faded and discolored; both sides of this wall will need repainting. The other walls are not as bad. Repainting is expected to coincide with repainting the gatehouse.

Best Case: \$3,730.00
\$0.28/Sq Ft; Estimate to repaint

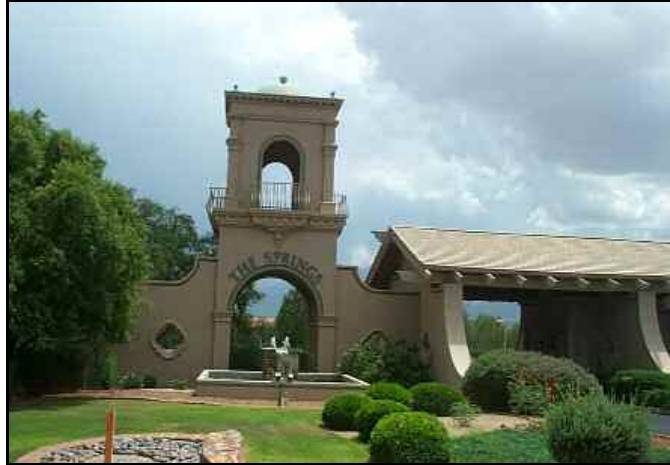
Comp #: 1115 Gatehouse Stucco - Repaint

Evaluation: The entire gatehouse area (stucco, wood, & metal) was last painted during 2001 for \$6,850. Some spots with higher sun exposure are already faded and chipped. Most of the stucco surfaces are still in decent shape.

Best Case: \$4,960.00
\$0.50/Sq Ft; Estimate to repaint

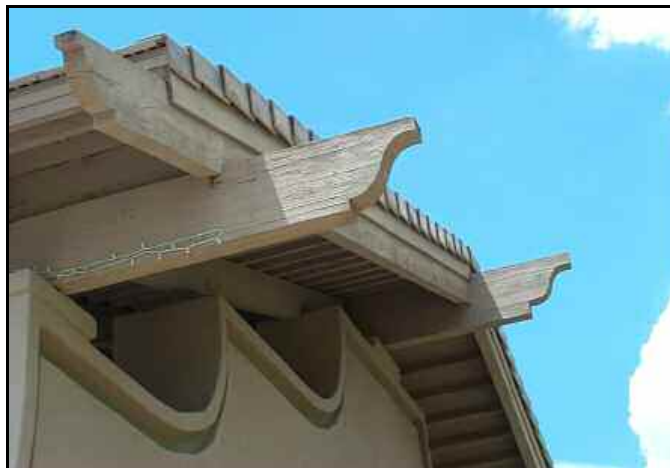
Comp #: 1116 Gatehouse Trim - Repaint

Evaluation: The exposure wood protruding from underneath the tile roof was last painted during 2001 with the stucco. Surfaces already exhibit a lot of fading and weathering. Some of the wood is rotted. Expect to paint this wood around the roof perimeter more frequently than the stucco.

Best Case: \$1,060.00
\$1.00/Sq Ft; Estimate to repaint/repair

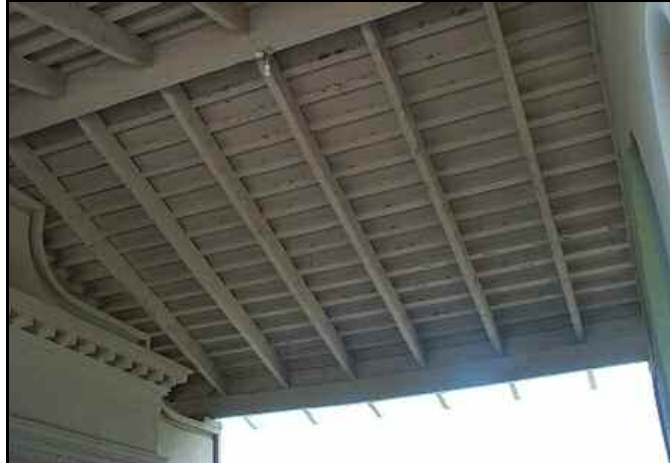
Comp #: 1117 Gatehouse Wood - Repaint

Evaluation: Wood underneath the tile roof has likely never been painted. It is not exposed to the sun and has only minimal weather exposure. Repainting is anticipated in the near future.

Best Case: \$2,020.00
\$0.40/Sq Ft; Estimate to repaint

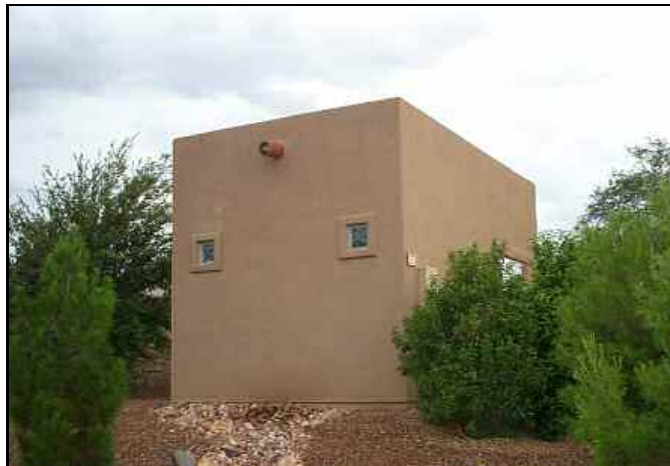
Comp #: 1120 Maintenance Building - Repaint

Evaluation: This building has a color coat surface, it is not painted. The coating will eventually fade and need to be painted. Life span reflects paint, and the remaining life span reflects the color coat surface.

Best Case: \$550.00
\$0.60/Sq Ft; Estimate to repaint

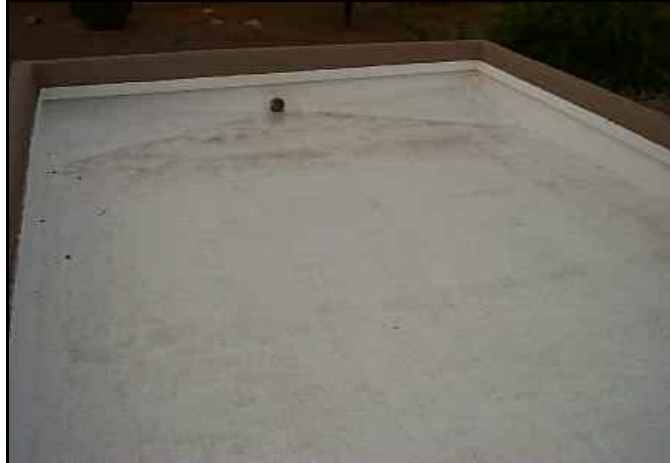
Comp #: 1301 Flat Roof - Replace

Evaluation: This building has a cap sheet roof with an elastomeric coating. Roof feels solid and looks good. Replacement should be anticipated eventually.

Best Case: \$770.00
\$2.80/Sq Ft; Estimate to replace

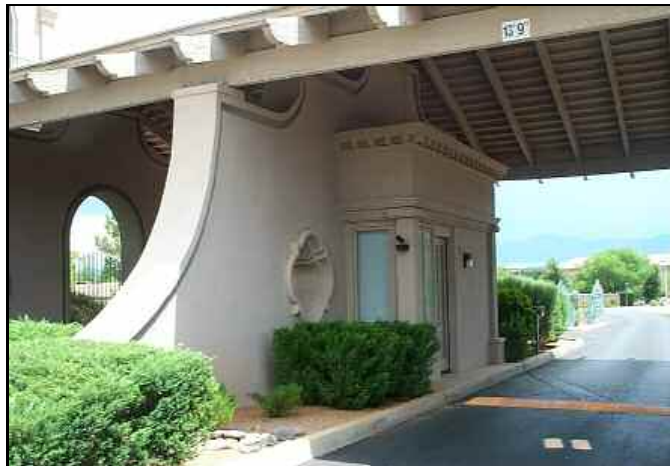
Comp #: 1302 Flat Roof - Replace

Evaluation: The office section has a small, flat roof. Original from 1996. No access to inspect. This roof is protected by the main tile roof, so it never receives sun or weather exposure. Replacement is not anticipated at this time.

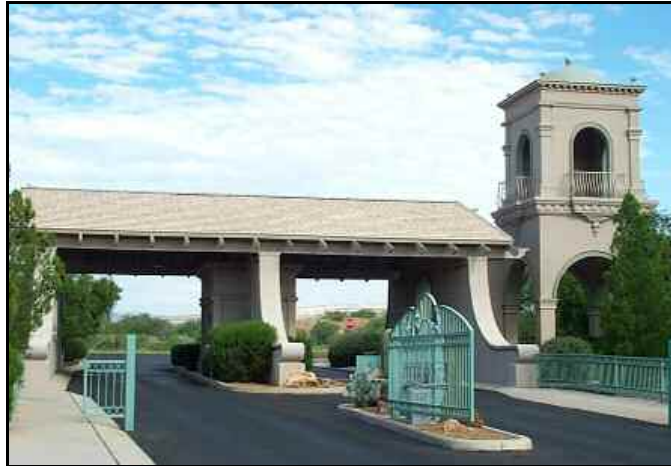
Comp #: 1304 Tile Roof - Repair

Evaluation: The main roof area has flat, concrete tiles. No missing or damaged tiles observed. There is no expectancy to completely replace this roof. Tiles are expected to last indefinitely. The felt paper underlayment will eventually need replacing though. This component funds to remove the tiles, replace the underlayment, and reinstall the tiles.

Best Case: \$6,800.00
\$2.50/Sq Ft; Estimate to repair roof
