“Full” Reserve Study

The Springs at Santa Rita HOA Green Valley, Arizona

Report #: 12303-0
For Period Beginning: January 1, 2005
Ending: December 31, 2005

Date Prepared: November 15, 2004

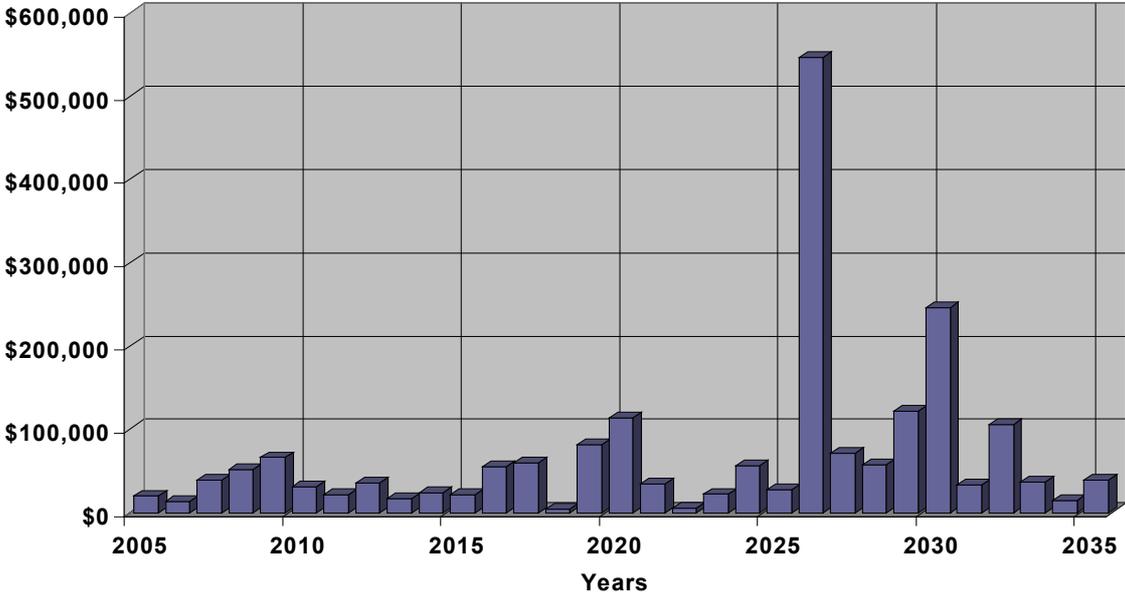
Figure 1

The figure below shows the array of the projected future expenses at your association. As with all computations in this Report, the estimates in this figure are based on the average of Best and Worst Case expense projections. As you can see, expenses are projected 30 years into the future, using the Inflation rate shown in the Executive Summary. This figure clearly shows the near term and future expenses your association will face. Note the large expenditure slated for 2026 primarily represents resurfacing the streets in Phase 1.

A summary of this information is shown in Table 4, while details of the projects that make up this information are shown in Table 5. Since this is a projection about future events that may or may not take place as anticipated, we feel more certain about “near-term” projects than those many years away. While this Reserve Study is a one-year document, it is based on 30 years worth of looking forward into the future.

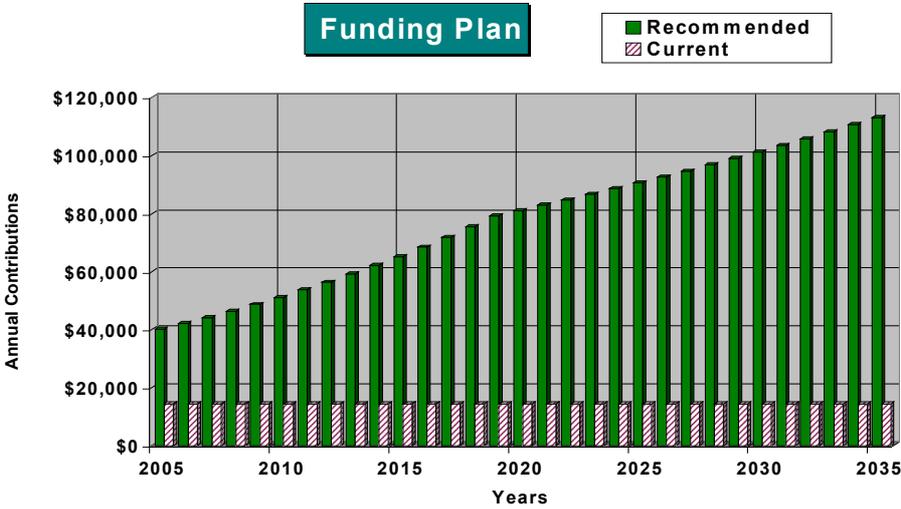
Figure 2

Based on your current Percent Funded and projected cash flow requirements, we recommend increasing/decreasing Reserve contributions to \$40,000 for the 2005 Fiscal Year. This represents the first year of a 30-year Funding Plan. To most fairly spread out the contribution burden over current and future owners in our inflationary economic environment, nominal annual increases of 5% should be expected in future years. This Reserve contribution rate was established by testing different funding options while balancing the four Funding Principles in an attempt to eventually achieve Full Funding. Generally, the tools we utilize are regular ongoing contributions (for stability and fairness), and special assessments (used only as a last resort). Our recommended multi-year Funding Plan is shown below. This same information is shown numerically in both Table 4 and Table 5.

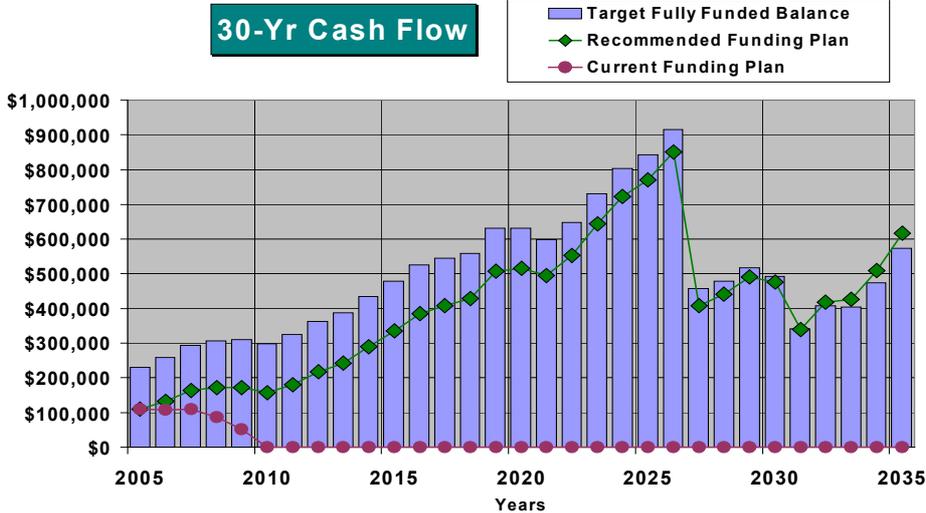
Figure 3

Your projected Reserve Balance as a result of following this Recommended multi-year Funding Plan and your Current Funding Plan is shown below, compared to your Fully Funded Balance target. This assumes the future expenses we have projected in this Reserve Study. While your Reserve Balance might seem high in future years,

remember that these figures are “inflated” future dollars. In addition, this Reserve Balance is necessary to prepare for expenses in following years and provide necessary “margin” for projects that will probably not occur exactly as planned.

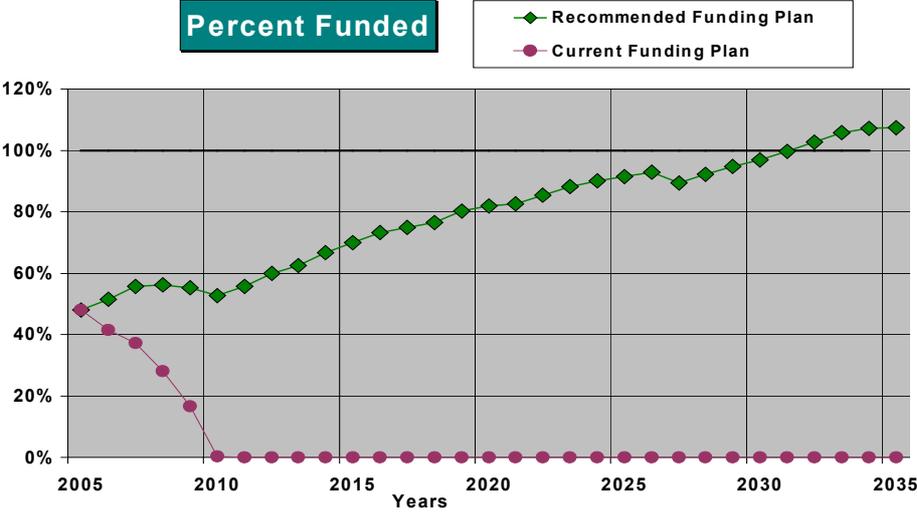
Figure 4

A simple comparison (a percentage comparison) of your Actual Reserve Balance to the moving Fully Funded Balance target is shown below. In this figure it is easy to see how your Reserve Fund gradually draws closer to the Fully Funded (100%) level.
