Update “With-Site-Visit” Reserve Study

The Springs at Santa Rita HOA Green Valley, Arizona

Report #: 12303-1
For Period Beginning: January 1, 2011
Ending: December 31, 2011

Date Prepared: March 31, 2011

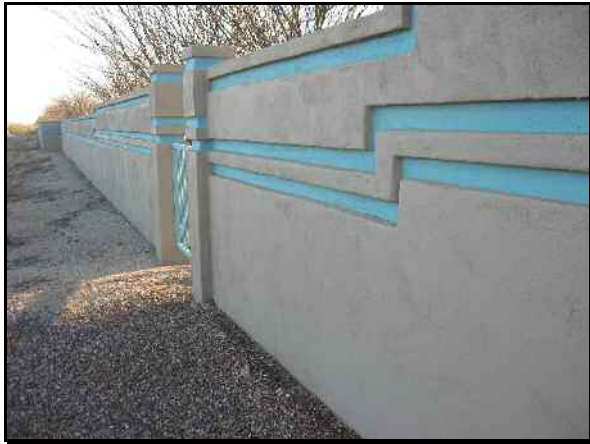
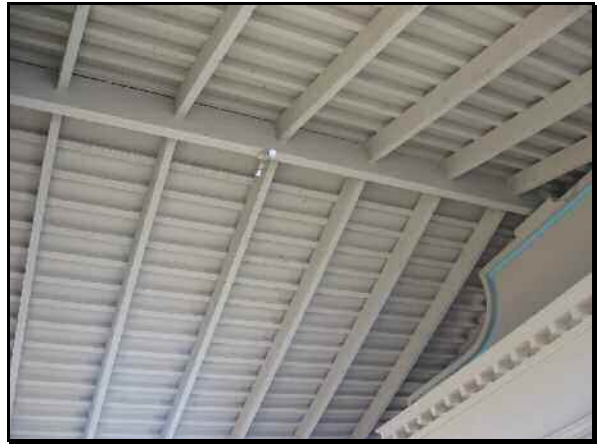
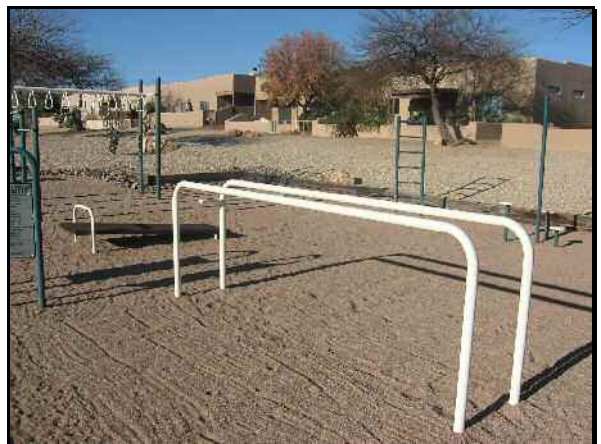
During our site visit on March 15, 2011, we started by meeting with several members of the Board. We discussed the previous report and what changes have occurred since then. We also discussed Reserve projects planned in the future. We then started the site inspection beginning with the common grounds. Next, we inspected the asphalt and sidewalks. Finally, we inspected the parks and walking trail.
